**New aspects of the genesis of the medieval
town walls in the Northern Baltic Sea region**

Academic dissertation

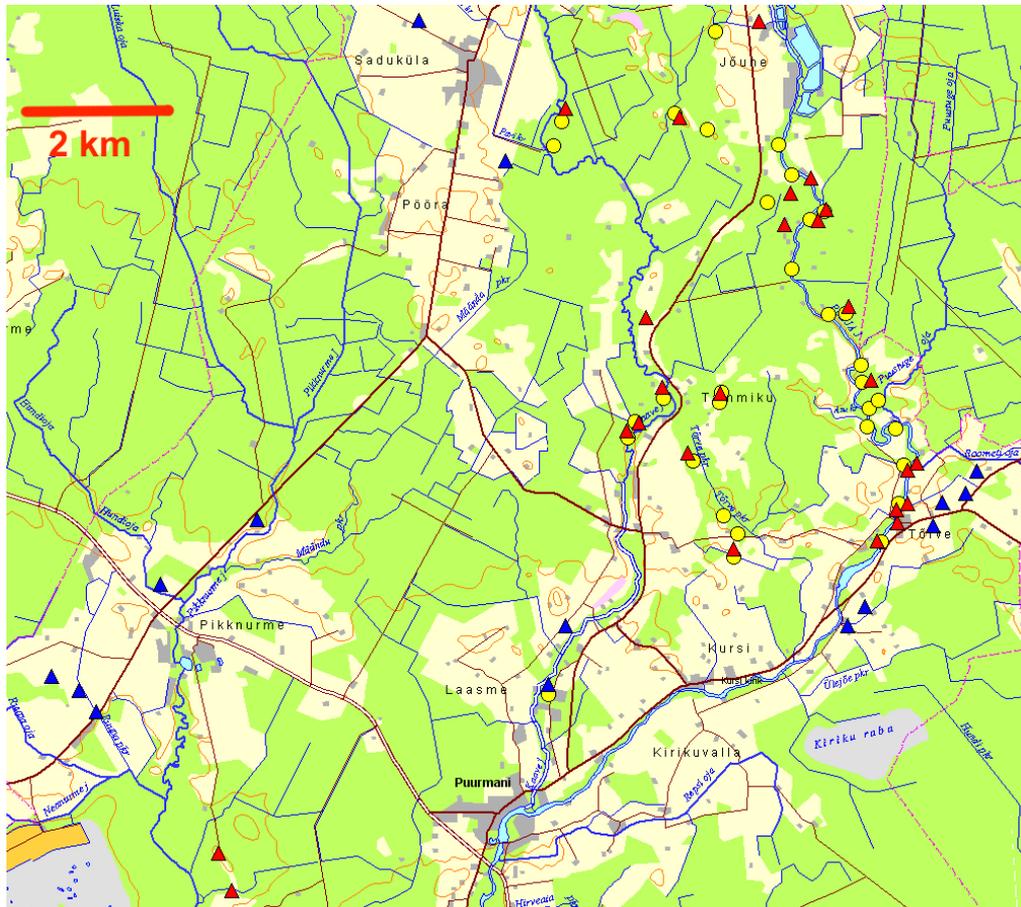
Figure 4. Lime production facilities in Kursi parish identified by the end of 2009. Red triangles – preserved limekilns or remains; Blue triangles – limekilns mentioned in written sources but indistinguishable on the landscape; Yellow circles – limestone quarries (Tvauri & Saimre 2010, fig. 1.)

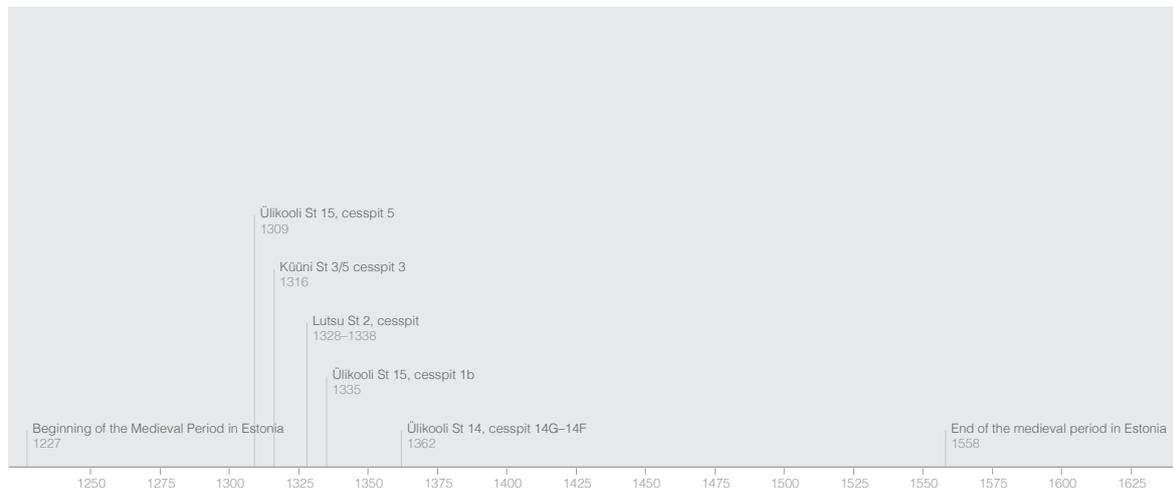
Figure 6. Timeline of the dendrochronological datings of the cesspits from Tartu. Rivo Bernotas.

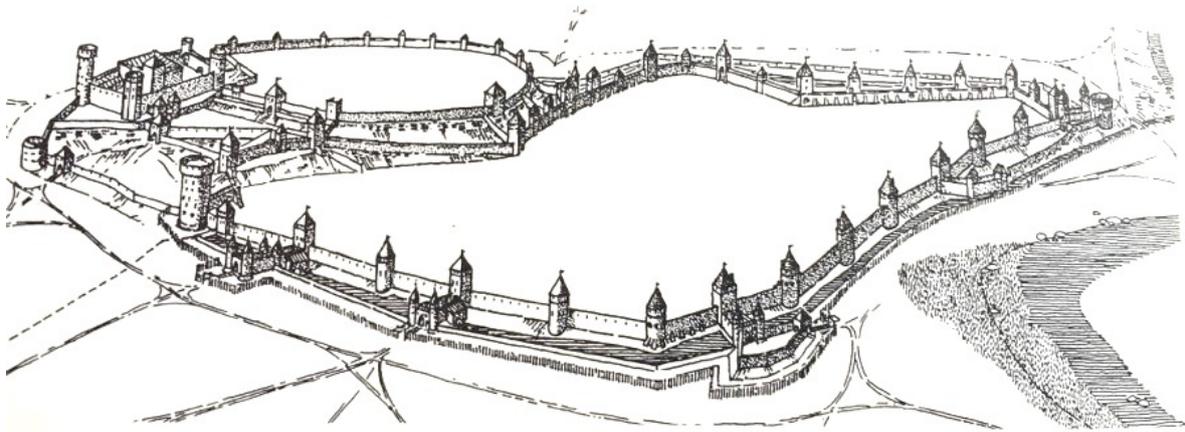
Figure 7. The fortifications of Tallinn in the 1530s. A view from the south-east. Reconstruction. (Zobel 1994).

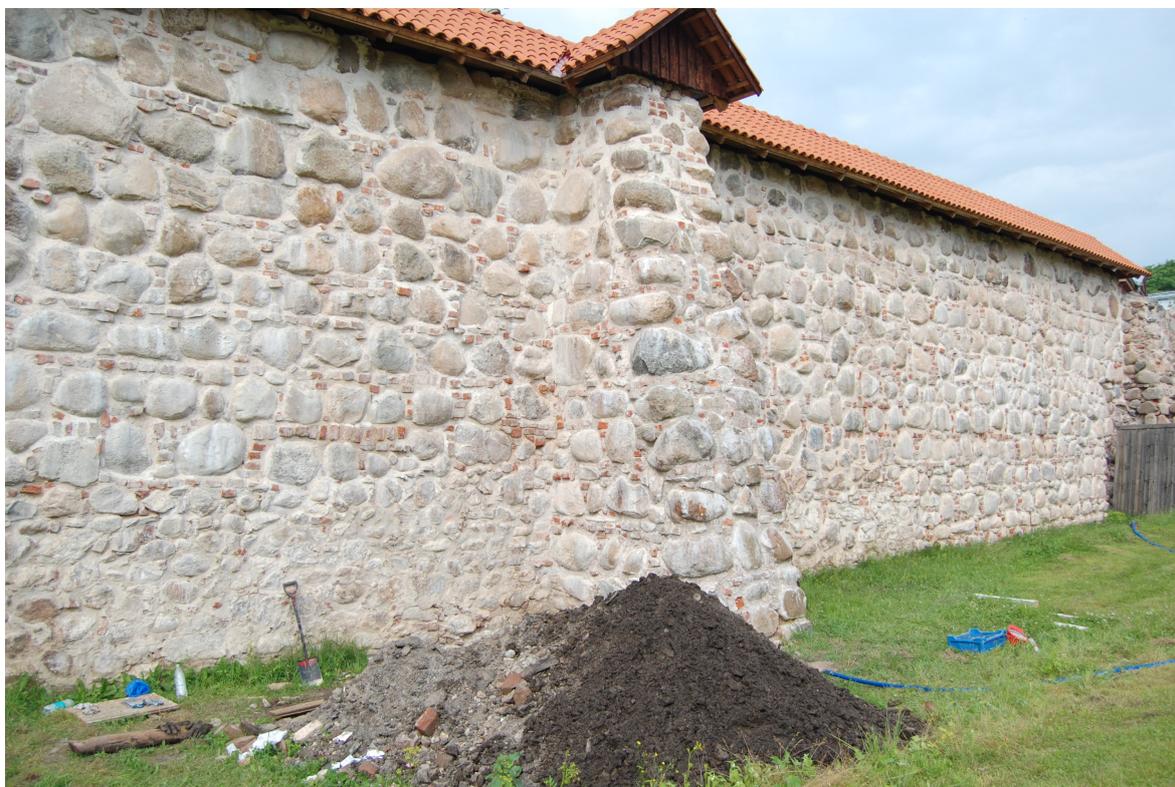
Figure 8. The renovated section of the town wall of Tartu in the riverside part of the town and the excavation pit in 2009. Photo by Rivo Bernotas.

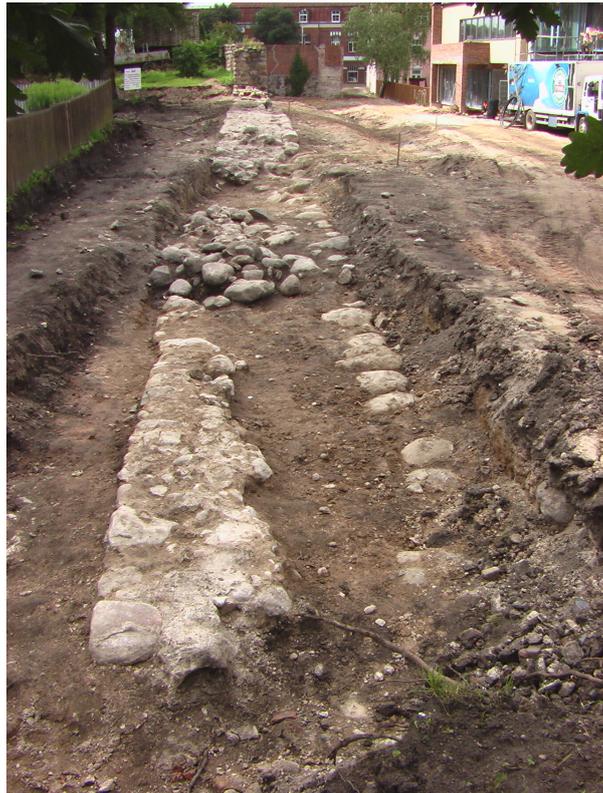
Figure 9. Excavated part of the town wall of Viljandi in the north/north-east part of the town. Photo by Peeter Piirits.

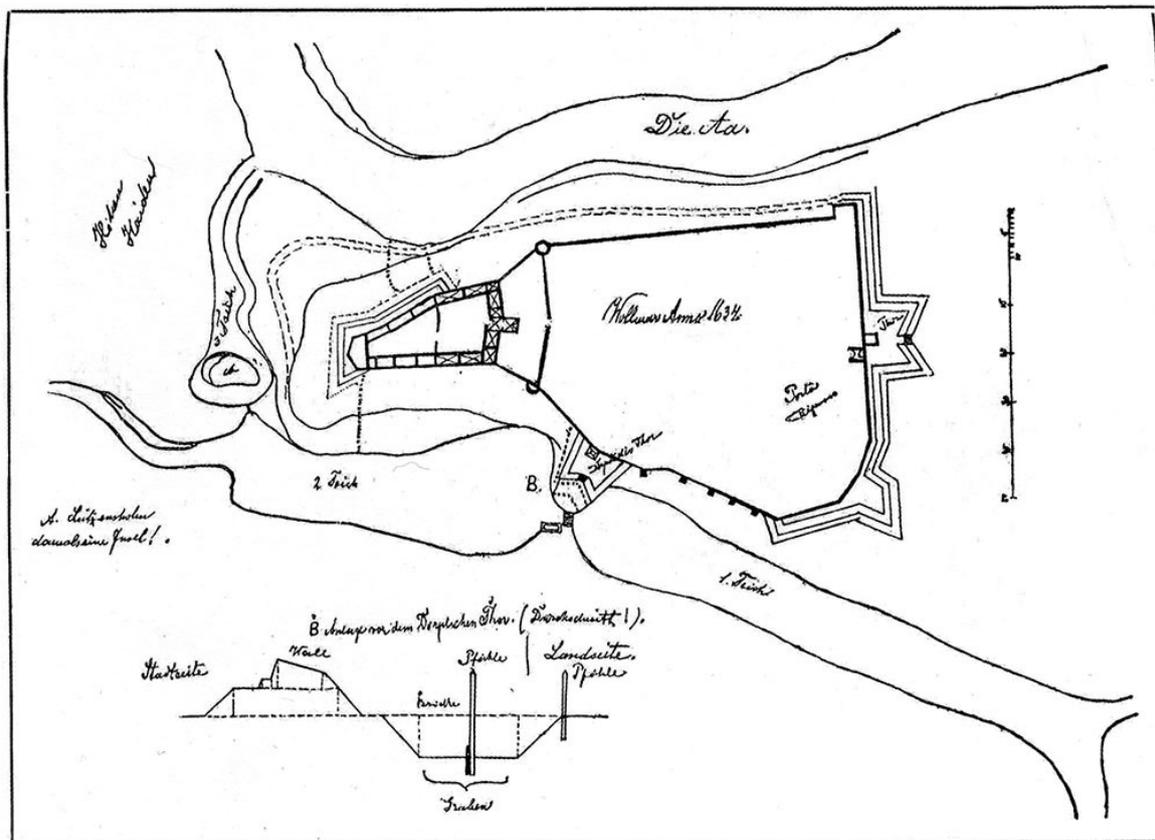
Figure 12. Fortification project of Valmiera from 1634, depicting the medieval town wall and projected bastions (Berga 2003).

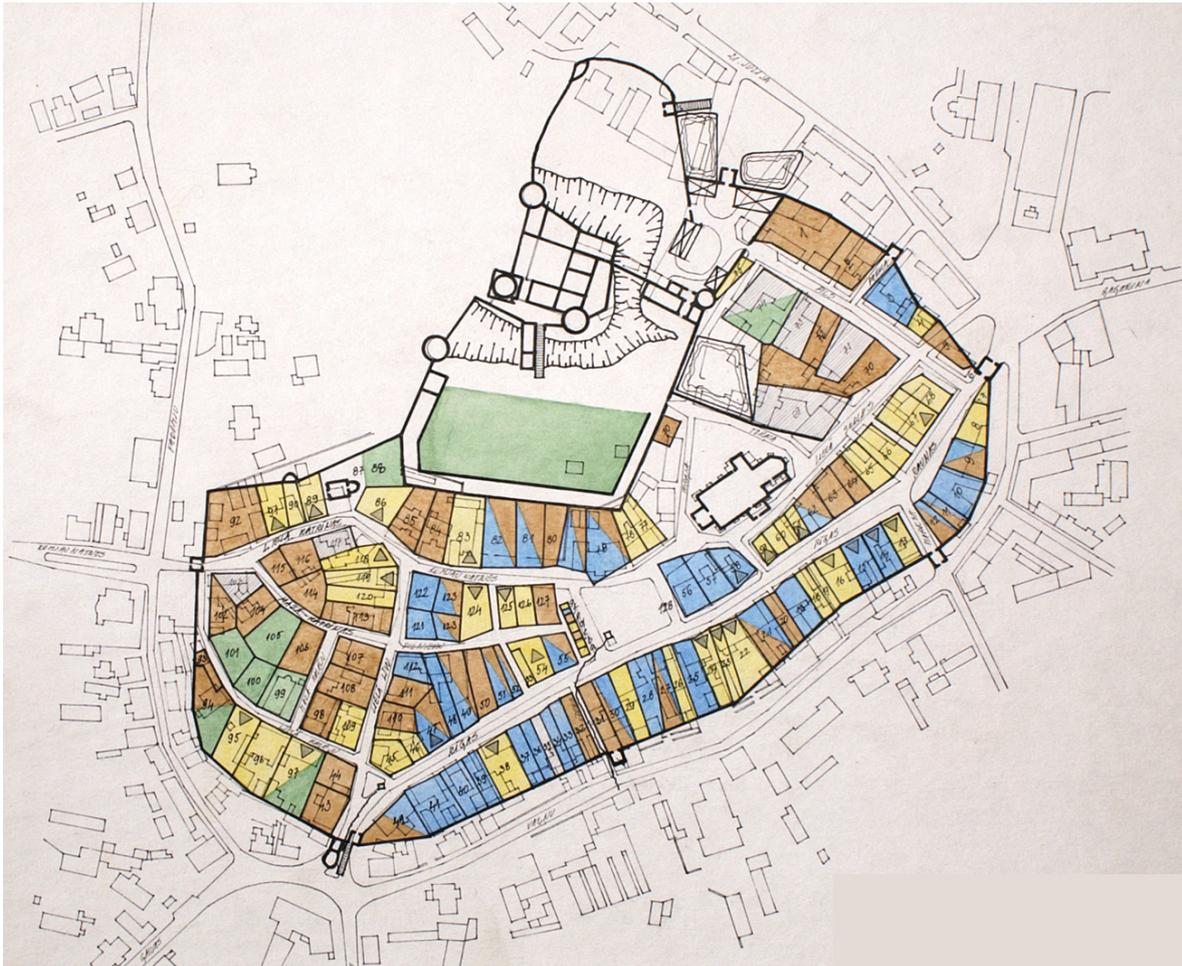
Figure 13. Town plan of Cēsis from 1693, modified to the 1988 plan (<http://www.cesis.lv/lv/pasvaldiba/buvvalde/regeneracijas-projekts/>).

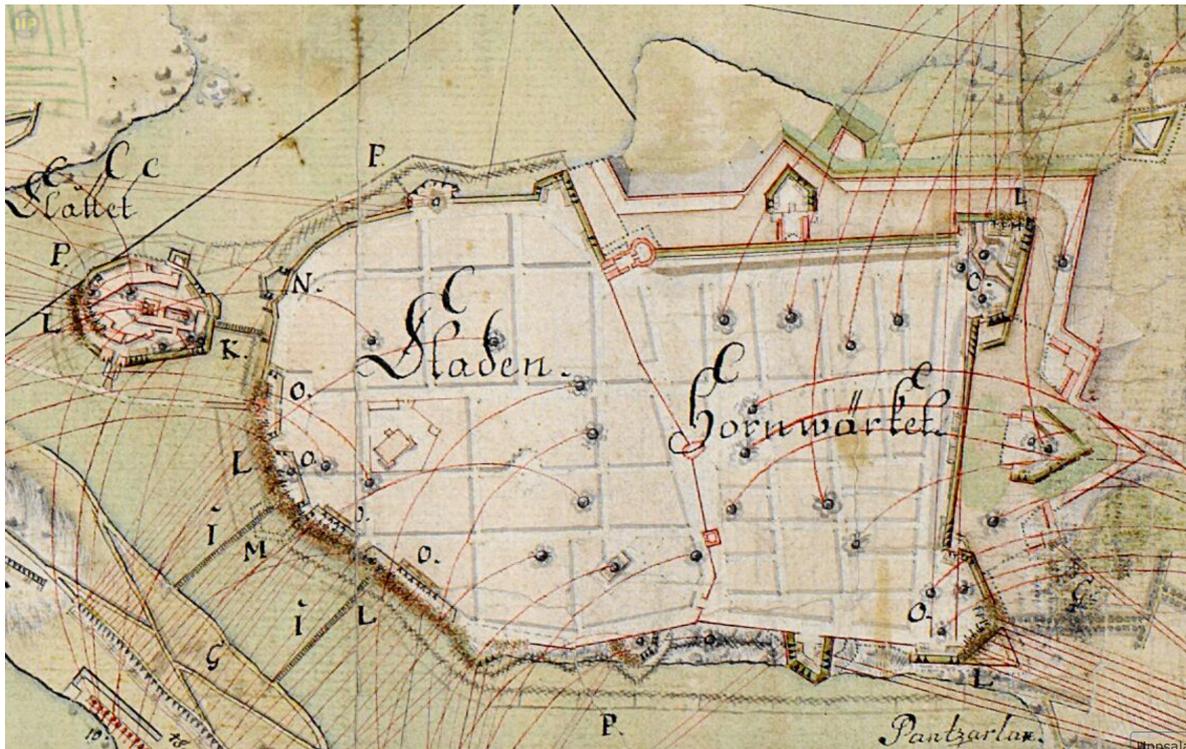
Figure 15. Town fortifications of Viipuri in 1710. Map from <http://art.alvin-portal.org/alvin/view.jsf?file=6131>, modified by Rivo Bernotas.

The construction of stone walls for the defence of the town that had emerged on the mainland cape began presumably at the beginning of the 1470s. The first mention of the town wall of Viipuri is dated to 1475⁸⁶ (Saksa 2012, 162 and the references therein; see Figure 15). The aims of the construction programme was to reinforce the kingdom's eastern border, which included not only the construction of the town wall of Viipuri but also Olavinlinna Castle (Taavitsainen 2007, 217), as well as to separate the bourgeois of the town from the countryside dwellers (Suhonen 2005, 190). The building of the large-scale fortifications in Viipuri was necessitated by the need to defend the frontier town against the more powerful Moscow State during the intensification of the struggle for domination in the Baltic Sea and the dramatic development of siege artillery (Saksa 2012, 162 and the references in there). The wall was constructed quickly and therefore without following the strict technical requirements (Saksa 2012, 169).

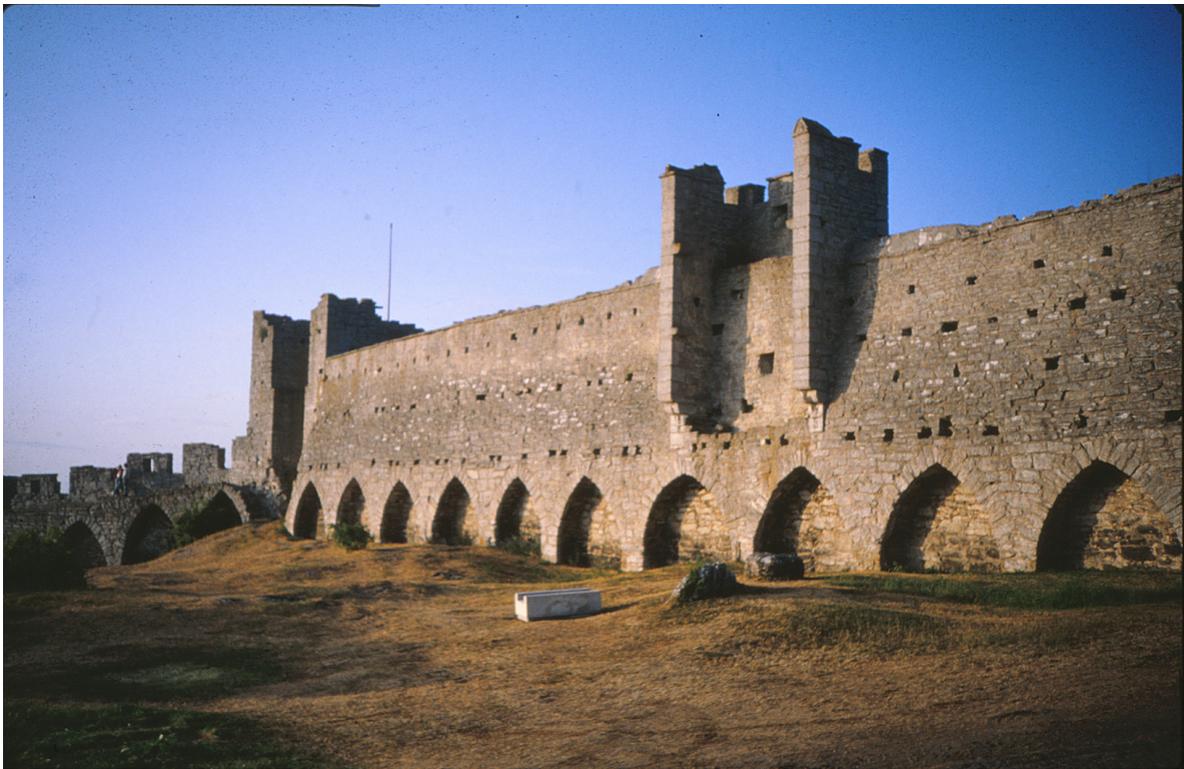
Figure 16. Northern part of the town wall of Visby. Photo by Andres Tvauri.

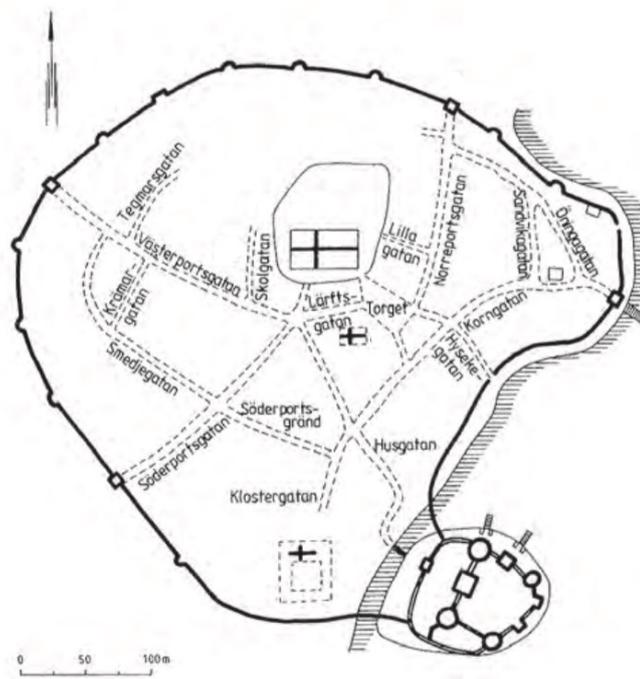
Figure 17. Reconstruction of the late medieval town plan of Kalmar (Frank *et al* 2010, figure 12).

Kalmar, on the east coast of the Swedish mainland, opposite Öland, was a typical colonial town of its period with a church on the market square, a couple of other ecclesiastical institutions, and a large castle (see Figure 17). The castle was located on an island, off from the town. German traders may have founded Kalmar at the end of the 12th century, as a joint venture with the Swedish monarchy (Blomkvist 1997, 69; see also Drake 2002, 153). Kalmar Castle has been also said to initially have served to check the activities of Swedish pirates (Kaufmann & Kaufmann 2001, 245).

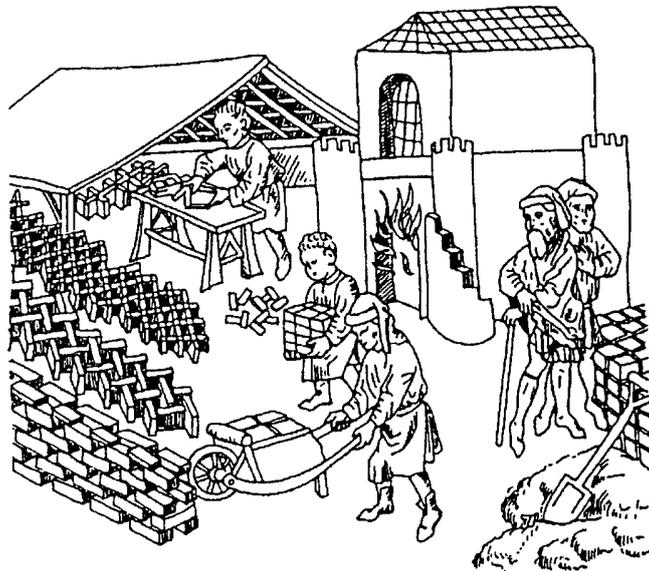
Fig. 1. Brick-making in the Netherlands (Binding 2004, 83).

Brick-making (Fig. 1) was one of the prerequisites for the implementation of various construction projects which were run by noblemen. Aristocracy was

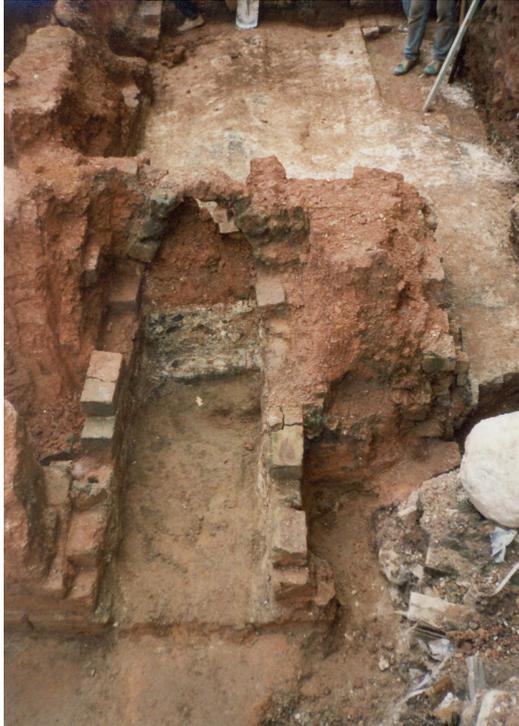
Fig. 4. Brick kiln from 1 Kitsas St. View from north. Photo by Rünno Vissak.

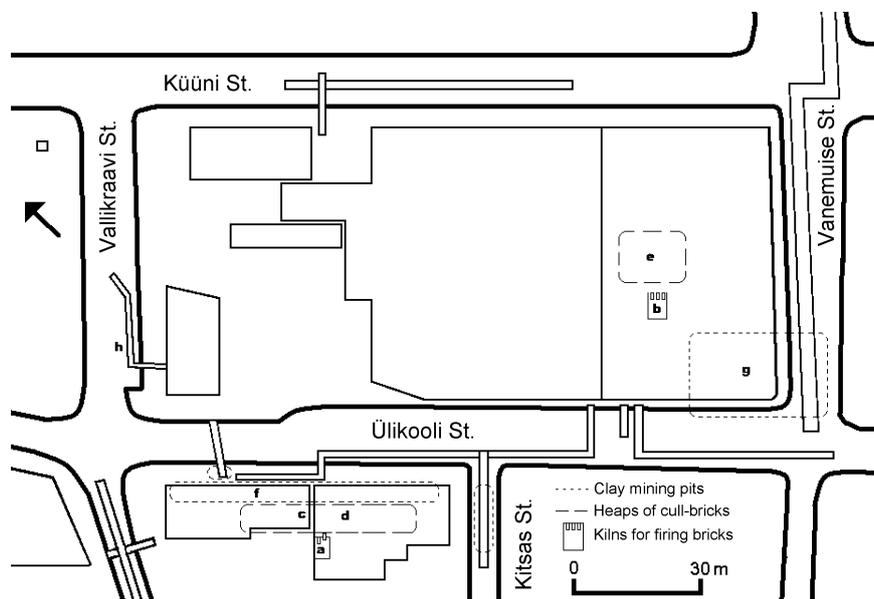
Fig. 5. The brick-making complex in the southern suburban area of Tartu (Heinloo 2006, 87; Fig. 3).

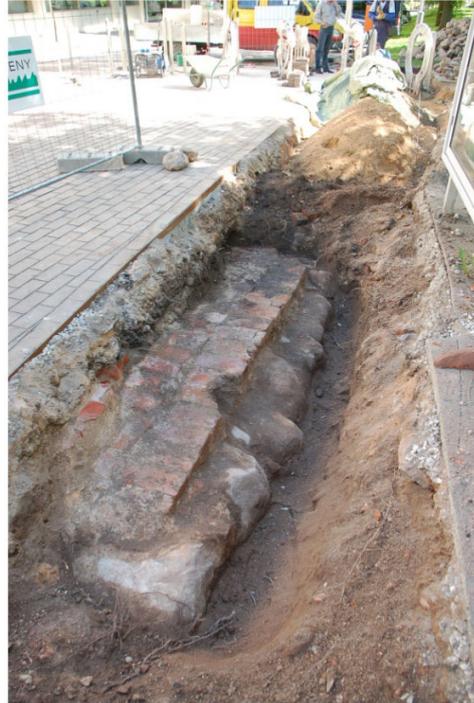
Fig. 6. Town wall on the north-east side of the crossroad of K uuni and Poe streets. View from south. Photo by Eero Heinloo.

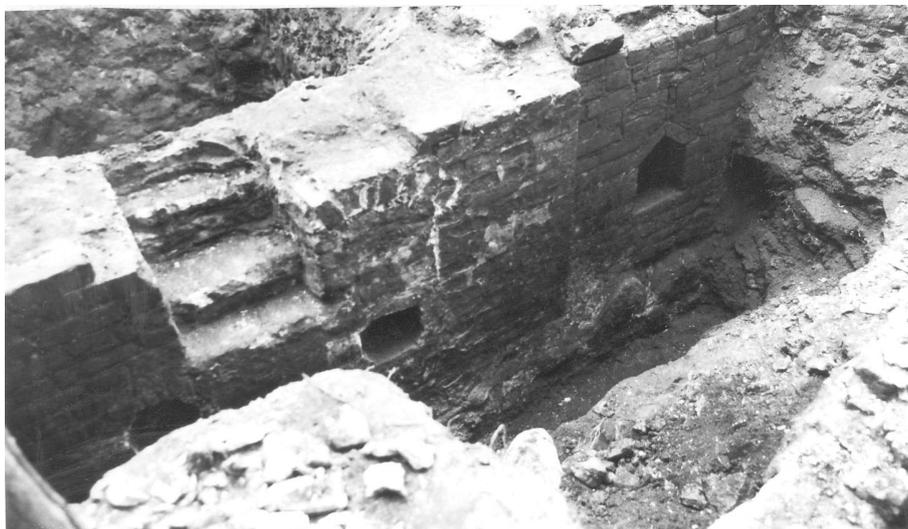
Fig. 2. Interior wall of the medieval stone building in Lossi Street (Metsallik 1987, fig. 2). Photo by Romeo Metsallik.

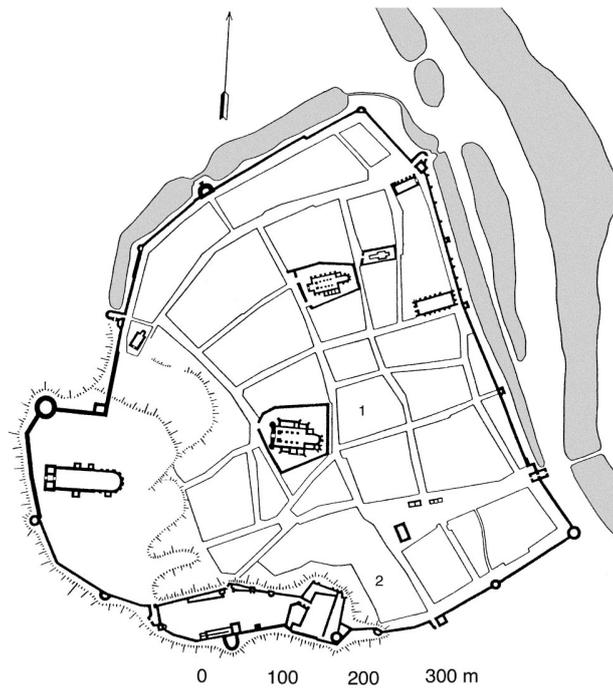
Fig. 1. Location of investigated latrines on the map of medieval Tartu. 1 Courtyard of 15 Ülikooli St., 2 Plot of 14 Ülikooli St. Drawing by Andres Tvauri.

The plot in 15 Ülikooli Street was situated right in the centre of Tartu surrounded by town wall, on the east side of Mary Church, which was the largest sanctuary in Tartu (Fig. 1). Latrine 1b is one of six latrines examined in courtyard

The plot on 14 Ülikooli Street was situated in the southern part of medieval Tartu, surrounded with the town wall, just on the foothill of medieval bishop's castle (Fig. 1). The latrine that was situated in squares 14G-14F (Fig. 4) in the grid formed in pit was excavated by archaeologist Peeter Piirits in 2007. The length of the box was 3 m and the width ca. 1.5 m. It was made of 20 cm thick pine logs and was limed from inside. The box had survived at the eight of nine log layers (2 m).

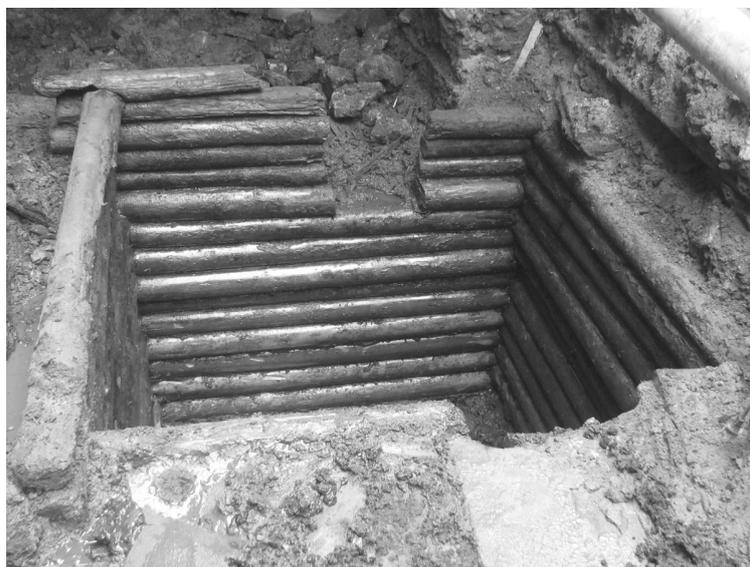
The side length of the quadratic corner-jointed log box (Fig. 2) measured from inside was 1.8 m. The box has been at least 15 log-levels high (1.9 m). Logs had been connected with dog-neck type connection, whereas the hollow of the corner tenon was hewed on the upper side of a log. As on some parts the bark is visible, it can be concluded that they were pine logs. The logs were 10 cm in diameter on an average. The box was surrounded by medieval cultural layer composed of loafs, branches, leather and other organic waste. Below the box the layer of decomposed peat emerged, into which the lowest log layer had sunk. Box 1b had been built inside a former and larger latrine (1a) (Tvauri 2007, 12).

Fig. 2. 15 Ülikooli St. latrine 1b. Photo by Andres Tvauri.

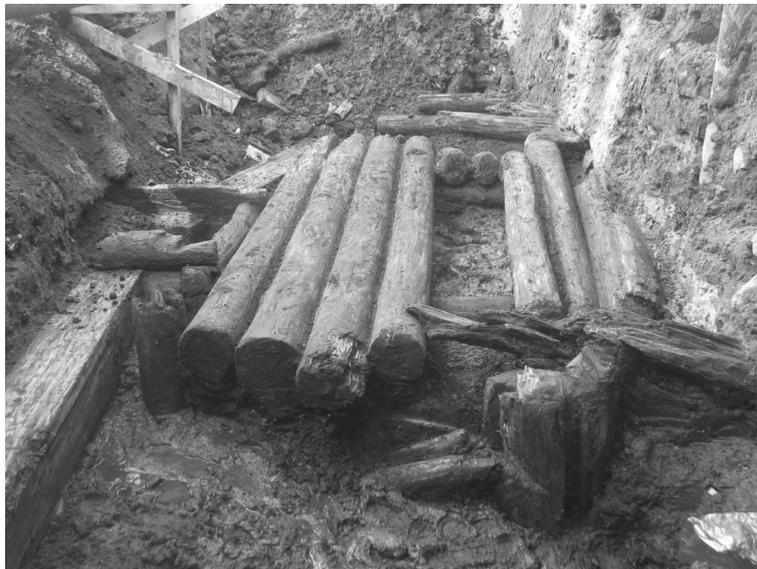
Latrine No 5 (Fig. 3) was situated on the east side of latrine 1b. From that only the logs covering the box could be cleaned and also the box of four highest log layers. Up to that height the box was filled in with later material. It was not possible to observe the initial content of the box – it was below the digging depth and will be conserved below the concrete floor of the cellar. From the stratigraphical location the box clearly dated from the Middle Ages, being on the same level and in the same direction with box 1b and surrounded with medieval cultural layer (Tvauri 2007, 14 f.).

The box was built of an average 15-cm-thick round pine logs. Logs were attached to each other with dog-neck tenon. The internal measures of the box were 1.4 m from east to west and at least 1.3 m from north to south. The latter measure could not be determined more precisely, as the upper part was probably destroyed with installing a wooden drain well in the 18th century (Tvauri 2007, 14 f.).

Fig. 3. 15 Ülikooli St. latrine 5. Photo by Andres Tvauri.

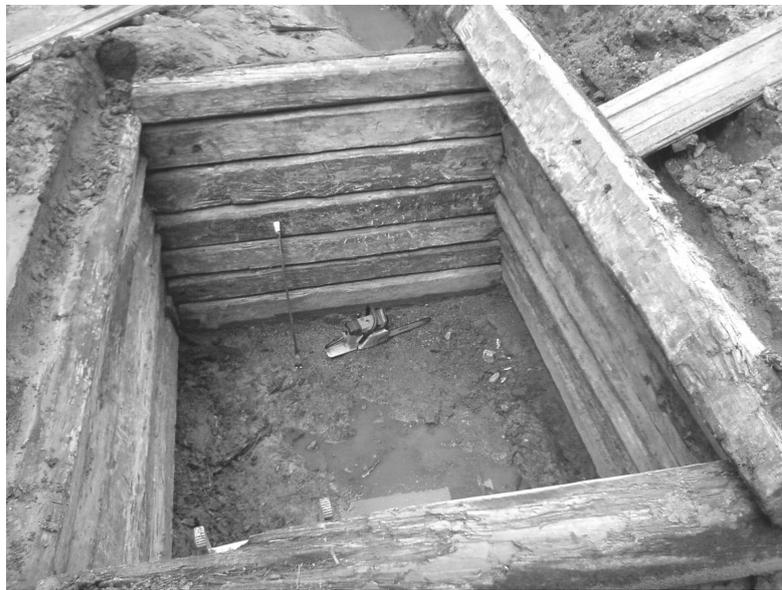
Fig. 4. 14 Ülikooli St. latrine 14G-14F. Photo by Rivo Bernotas.

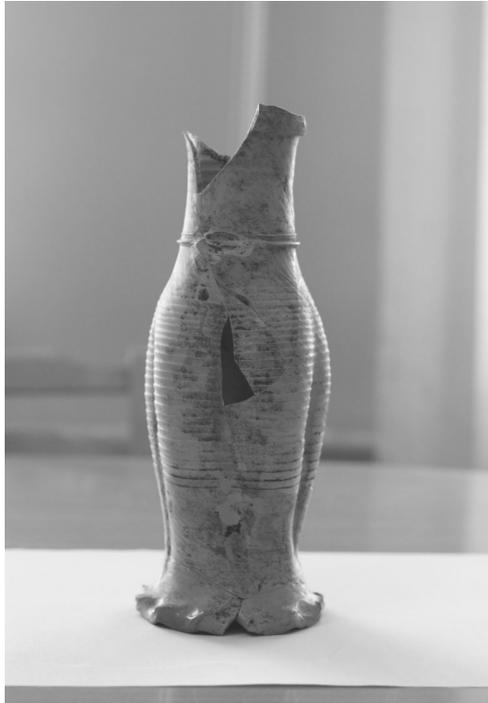
The interior of the latrine was filled in with dark and thick organics-rich manure layer, which included pieces of wooden tableware and ceramics, fragments of textile, pieces of glass, metal parts, etc. (Piirits 2008). The findings date back to the 15th century. For instance, there was an oval so-called Jacoba jug (Fig. 5), which had been manufactured in Waldenburg, western Saxonia (Russow 2006, 101, fig. 28: 1).

Fig. 5. Jacoba jug, found from latrine 14G-14F of 14 Ülikooli St. (TM A 133: 4264: 1, 2). Photo by Rivo Bernotas.

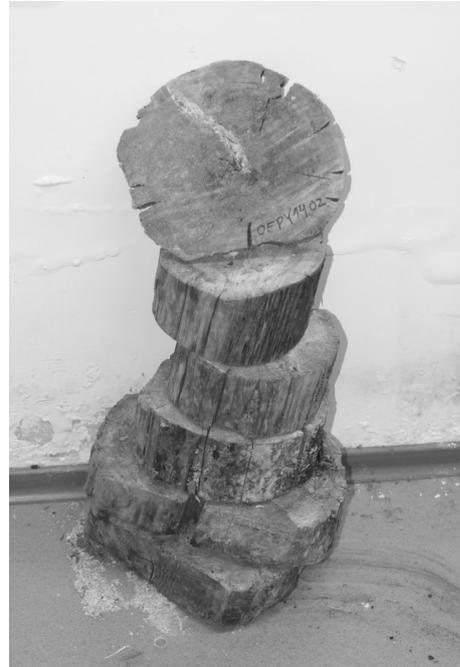
From latrine 14G-14F 13 sample discs were sawed (Fig. 8). Nine of them could be averaged to a 176 year long average *lepy1406*. Comparing it with pine chronologies from Gotland (3spgot01, $t = 4.11$, $W = 58.6$), Novgorod (3rpnov05, $t = 5.44$, $W = 62.9$), Tallinn town hall (3eptlr04, $t = 6.51$, $W = 66.3$) and Riga (3lptro01, $t = 5.31$, $W = 68.4$), the dendrochronological date was 1362 (Fig. 9).

Fig. 8. Test discs for dendrochronological dating from latrine 14G-14F of 14 Ülikooli St. Photo by Rivo Bernotas.

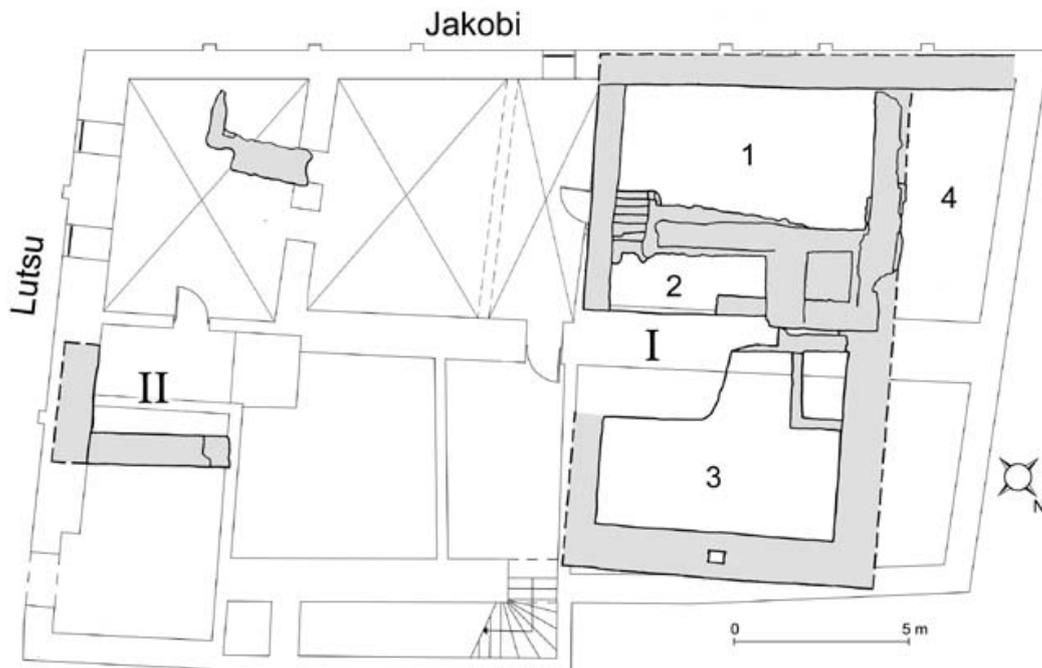
Fig 2. Medieval wall remains on the contour of the present building. Kristel Külljastinen.

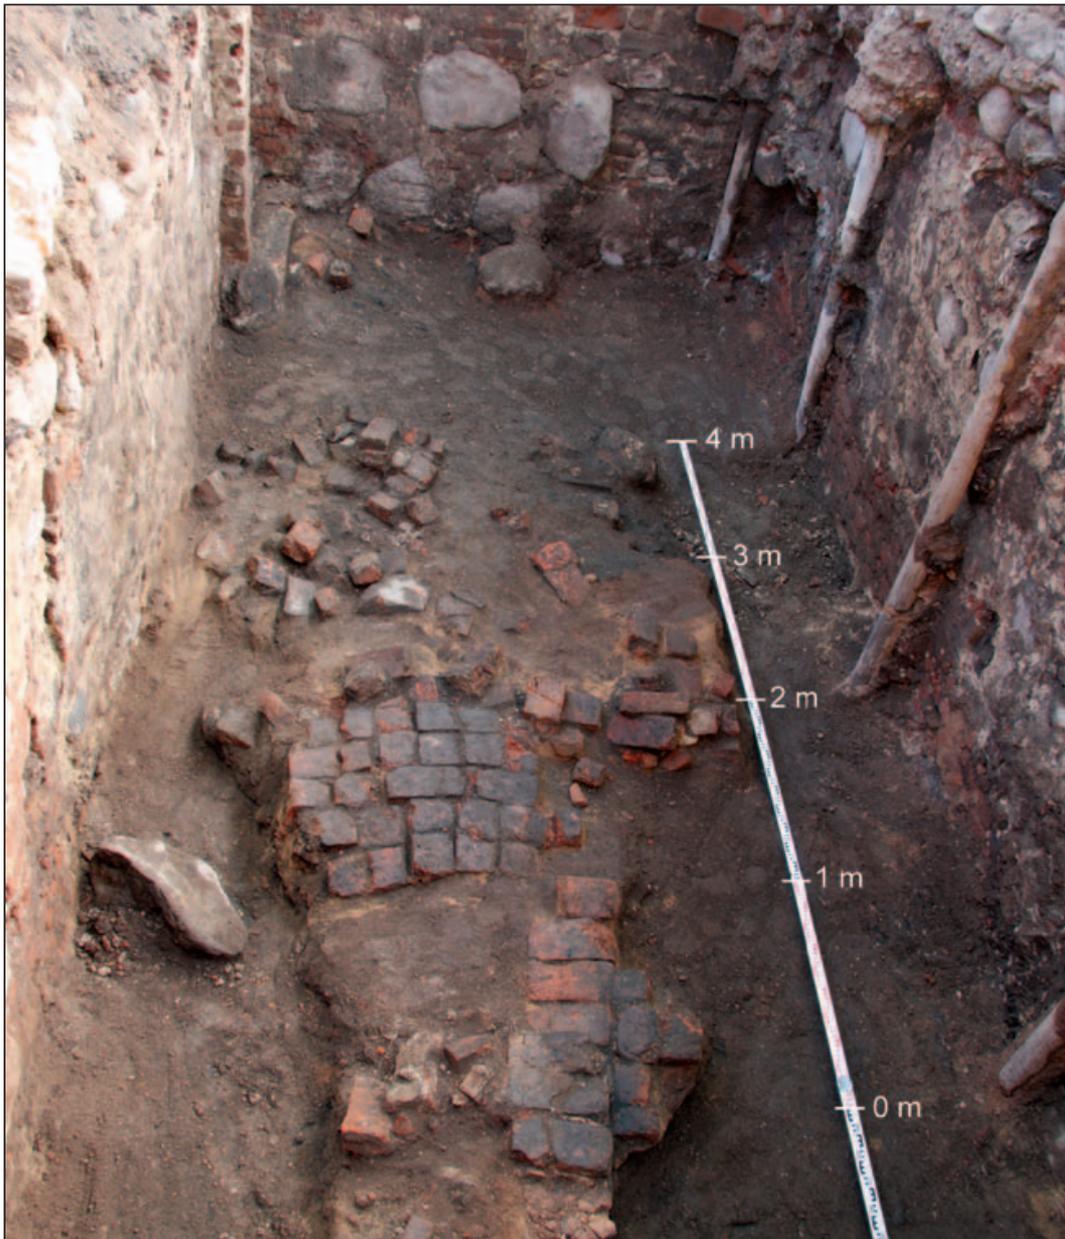
Fig 3. View of room 1 of medieval building I from the northwest. Kristel Külljastinen.

of more than two meters until the supporting structures of the partition joists of the main floor (Fig 3).

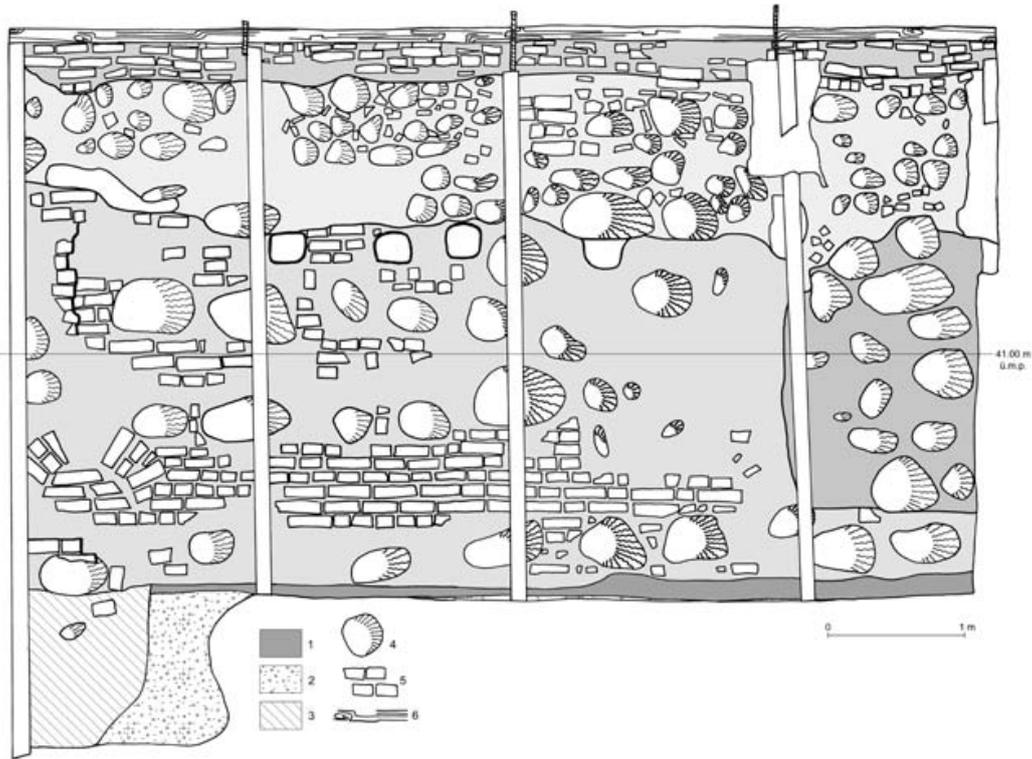
Fig 4. The southeastern wall of room 1 of medieval building I. Symbols: 1–black soil layer, 2–grey natural gravel, 3 – a pit , 4 – granite, 5 – brick, 6 – wood. Kristel Külljastinen.

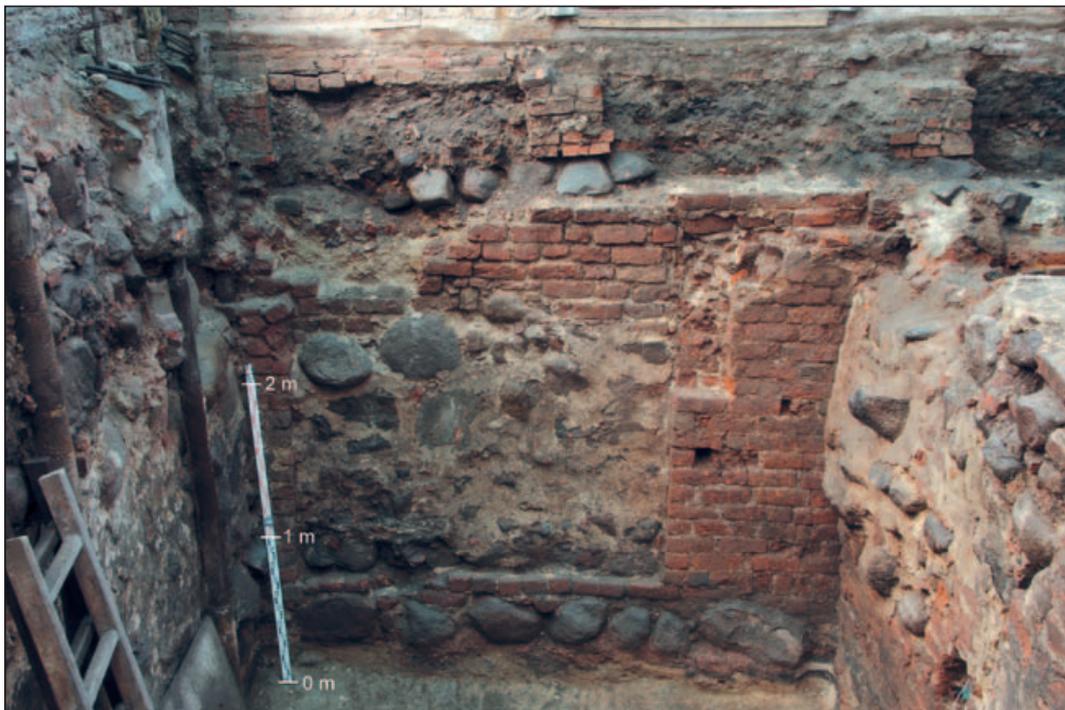
Fig 5. View of the northwestern wall of room 1 of medieval building II from the south-east. Kristel Külljastinen.

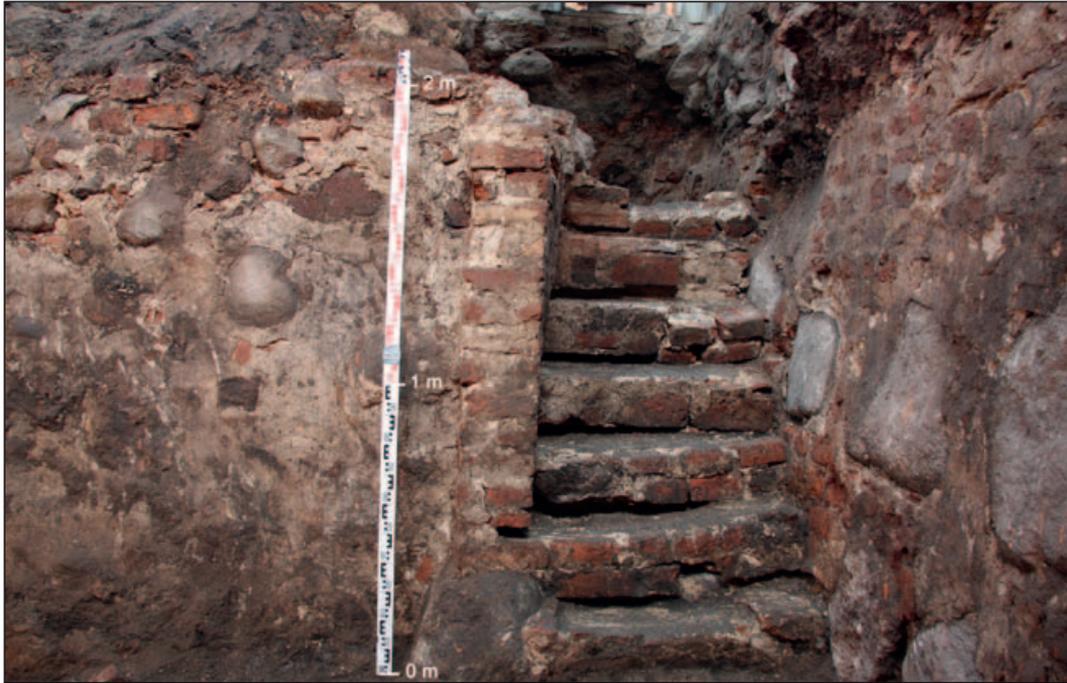
Fig 6. Part of the northeastern wall of room 1 of medieval building I, and a staircase. Kristel Külljastinen.

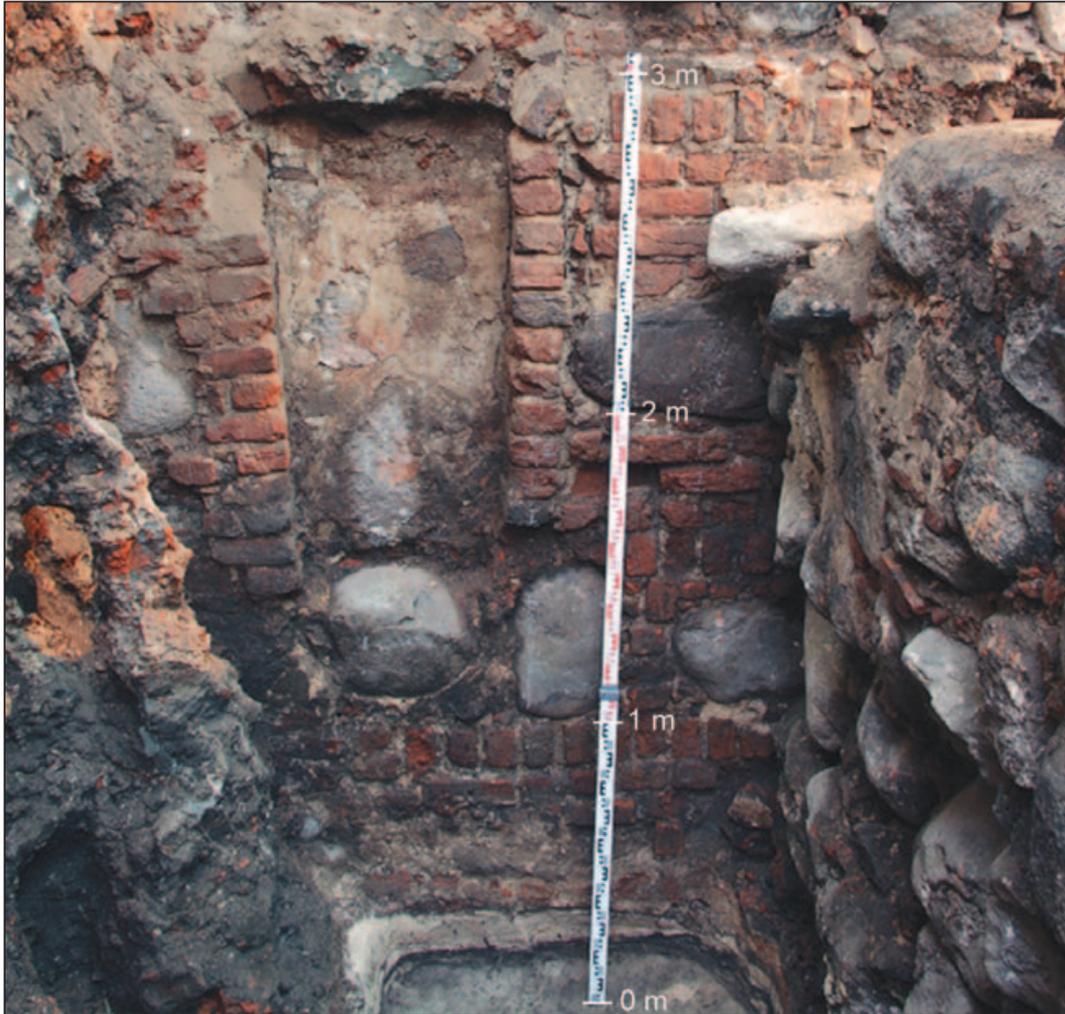
Fig 7. The southeastern wall of room 2 of medieval building I. Kristel Külljastinen.

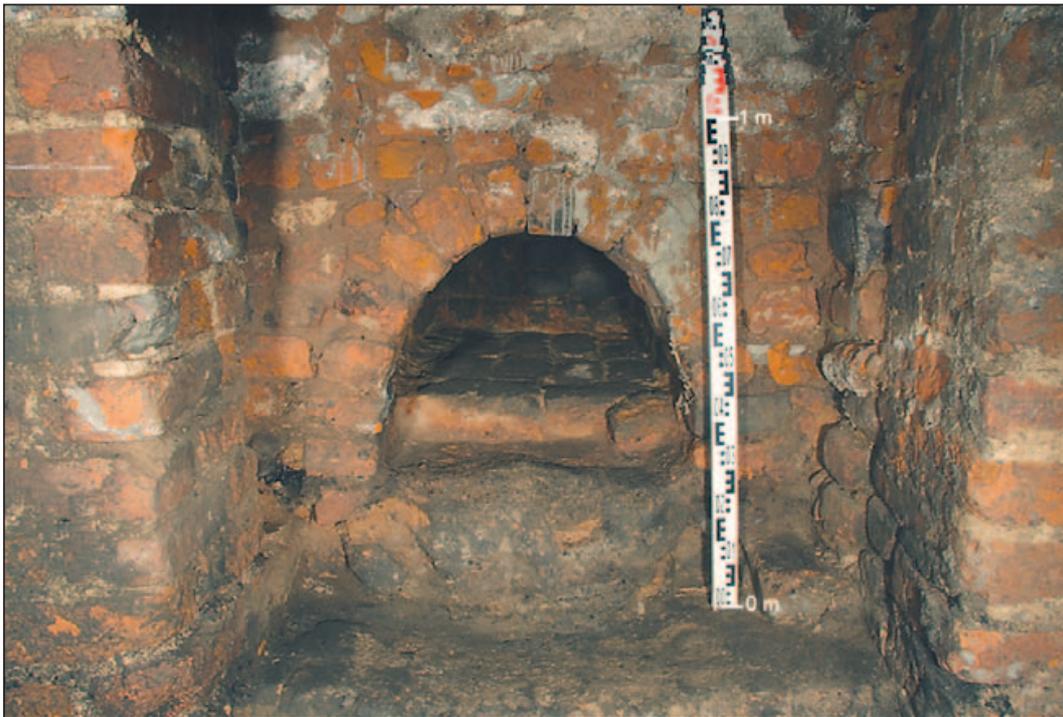
Fig 8. View of the orifice of the stove-hypocaust from the northeast. Kristel Külljastinen.

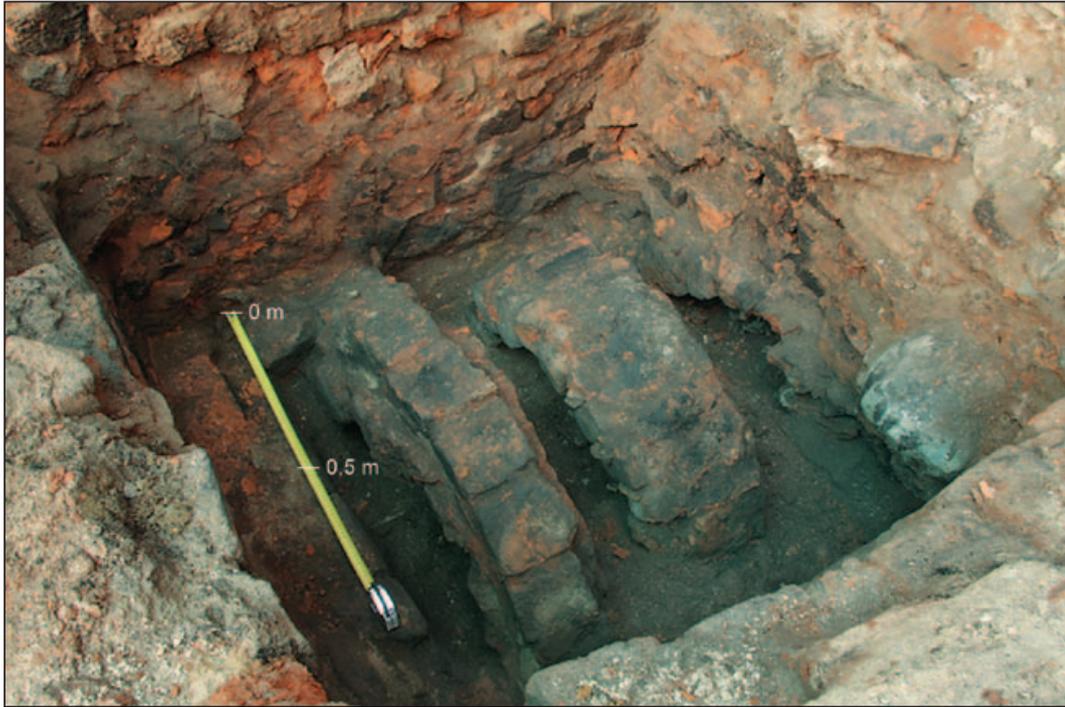
Fig 9. View of the inner vaults of the stove-hypocaust from the south. Kristel Külljastinen.

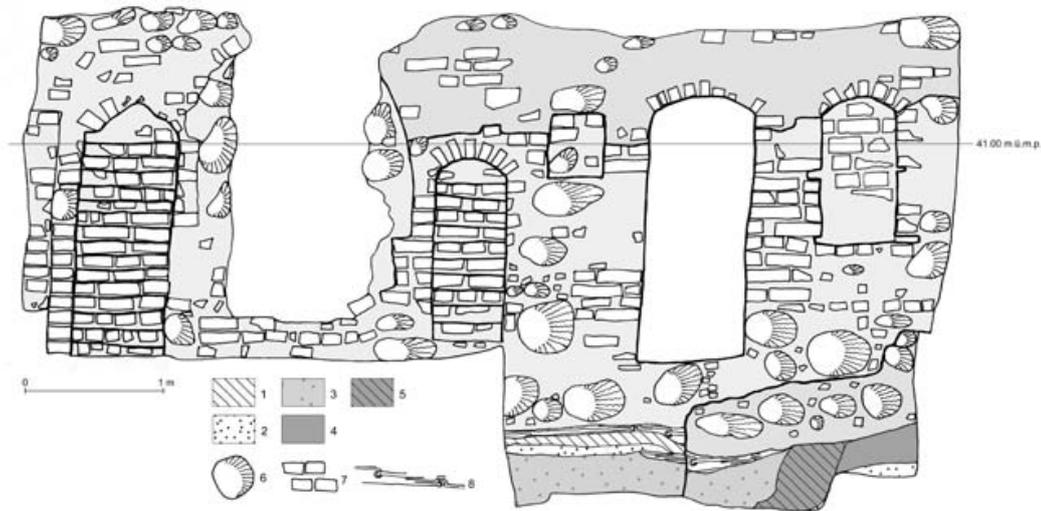
Fig 11. The northeastern wall of room 3 of medieval building I. Symbols: 1 – dark-grey rubble layer, 2 – natural river lime, 3 – brown layer with brands, 4 – black soil layer, 5 – mixed black soil layer, 6 – granite, 7 – brick, 8 – wood. Kristel Külljastinen.

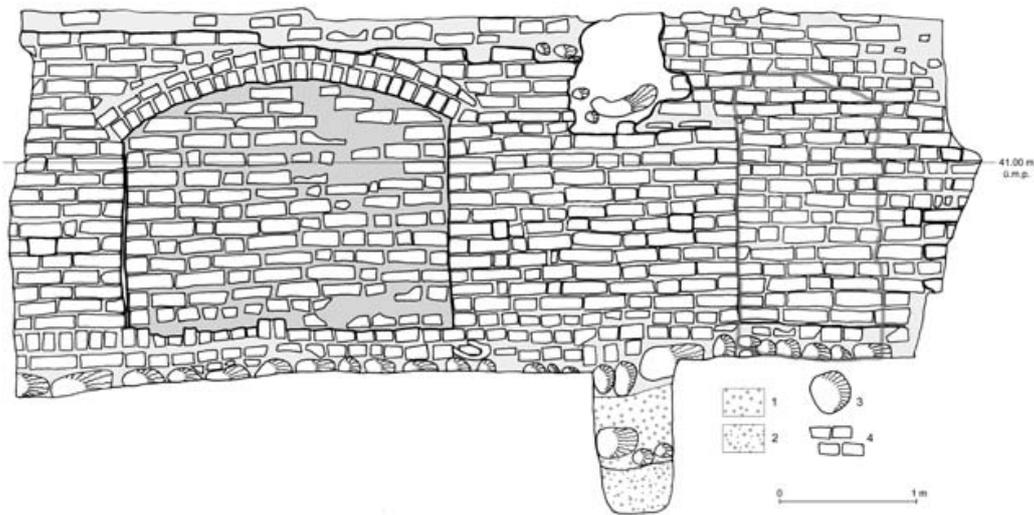
Fig 12. The southeastern wall of room 4 of medieval building I. Symbols: 1 – yellowish gravel, 2 – grey natural gravel, 3 – granite, 4 – brick. Kristel Külljastinen.
