**New aspects of the genesis of the medieval
town walls in the Northern Baltic Sea region**

Academic dissertation

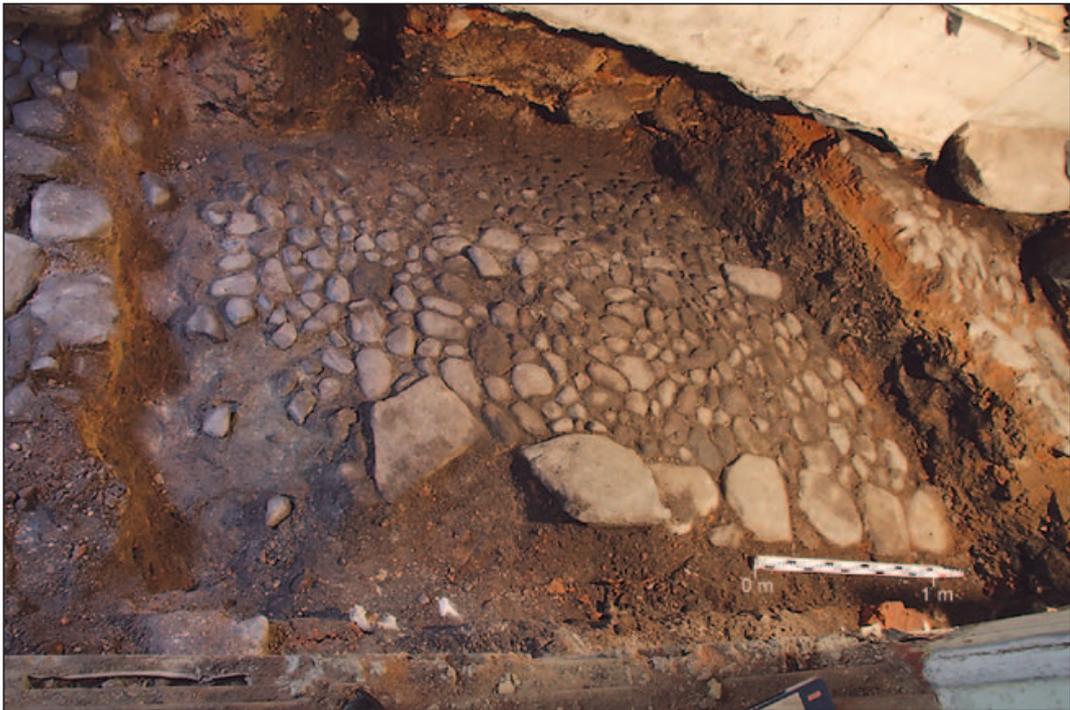
Fig 13. View of the lower paving above room 4 of medieval building I from the south-east. Kristel Külljastinen.

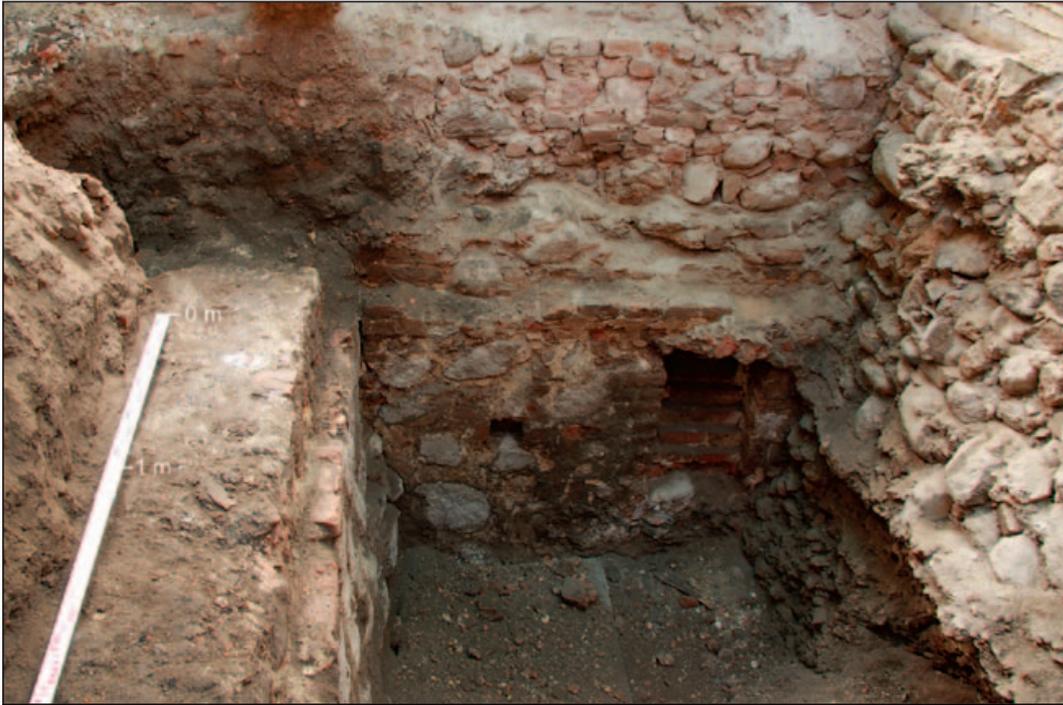
Fig 14. View of the remains of the walls of medieval building II from the northwest. Kristel Külljastinen.

The northeastern and southeastern walls of the ground floor (Fig 14) of the unearthed stone building have been preserved up to a height of 2 m and were simultaneously established on the above-described reddish planning layer. The walls of bricks and boulders were erected on the foundation consisting of boulders. In the upper part of the preserved sections of both walls, there is a 14–18 cm deep step that supported the former ceiling

construction. The thickness of the northeastern wall below the step is approximately 105 cm and above the step approximately 90 cm. A 100 cm high and 55 cm wide shaft (Fig 14 and 15) is situated in the southwestern part of the southeastern wall. Both the edges of the shaft as well as the diagonally risen plane have been laid of bricks. A 15×18 cm big and approximately as deep hole, probably established for the scaffolding, is situated in the northeastern part of the same wall. Both walls were plastered. The initial floor was a 5–10 cm thick layer of light lime mortar of even composition.

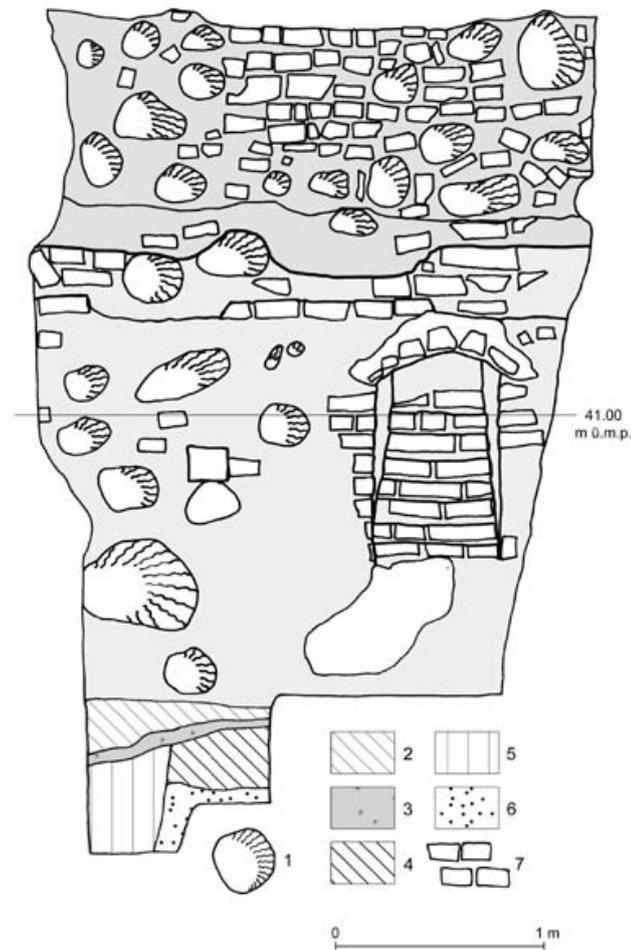
Fig 15. The southeastern wall of medieval building II. Symbols: 1 – granite, 2 – reddish rubble layer, 3 – burnt layer, 4 – dark soil layer, 5 – a post hole, 6 – natural river lime, 7 – brick. Kristel Külljastinen.

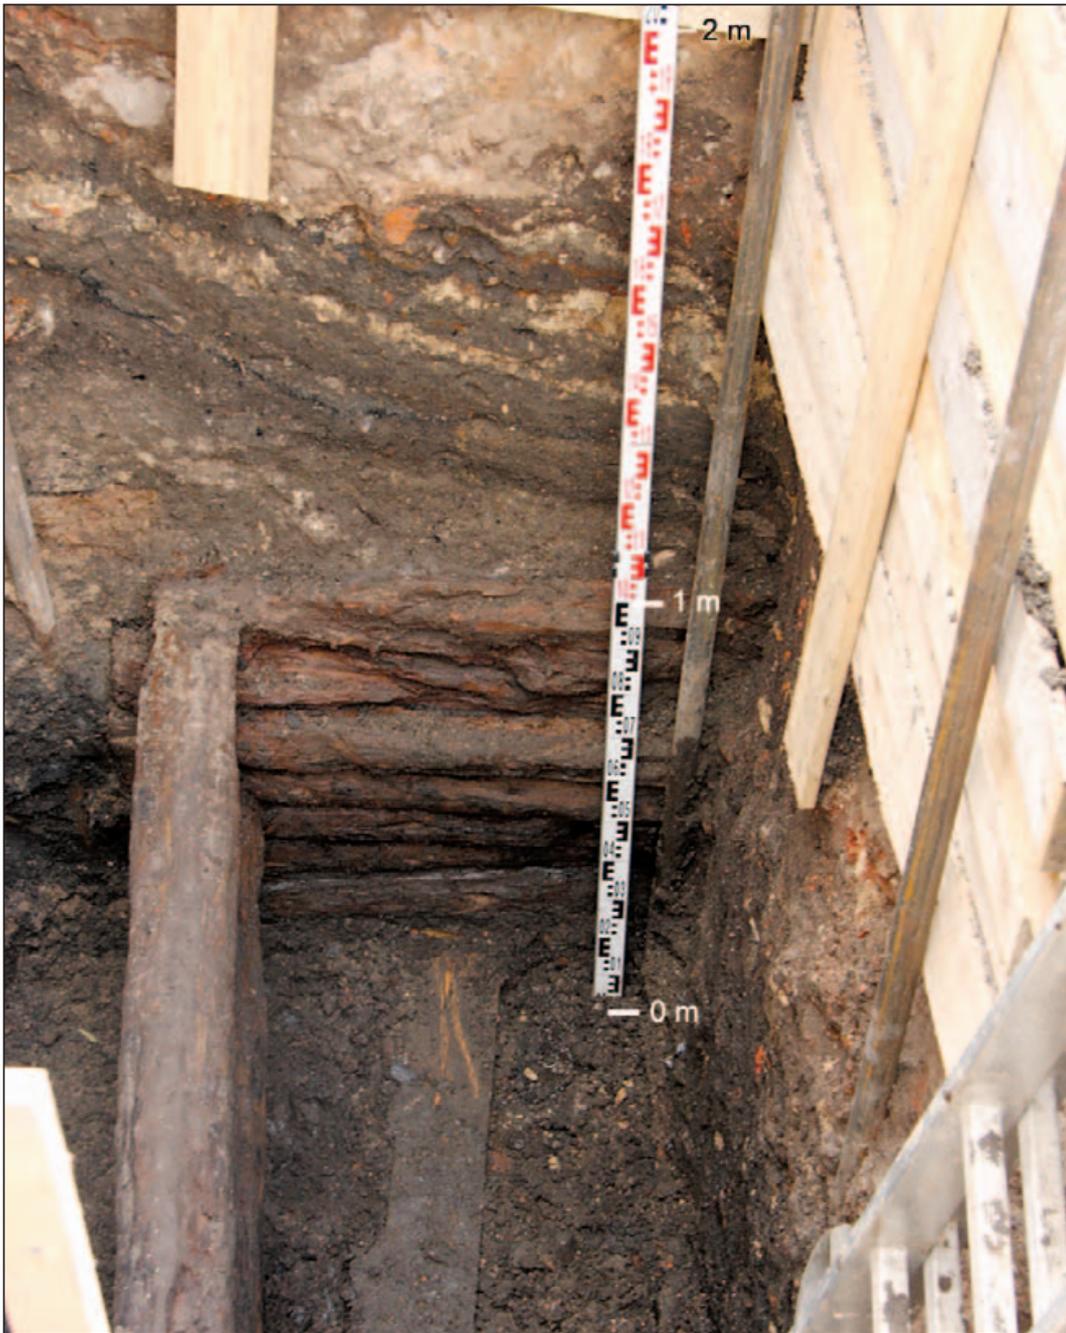
Fig 16. View of the partly excavated latrine bin from the southeast. Kristel Külljastinen.

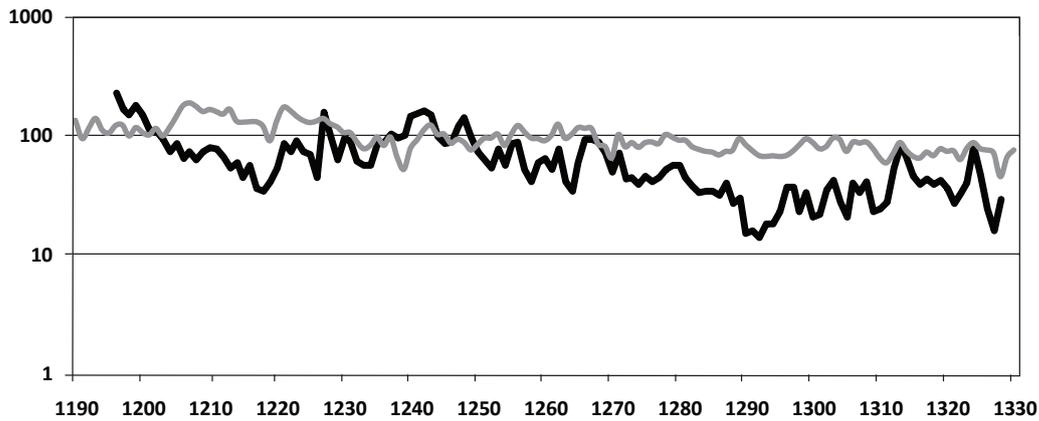
Fig 17. The average of samples of latrine from 2 Lutsu Street (black line) in Estonian pine chronology (grey line). Y-axis marks the width of annual ring and x-axis marks the years. Rivo Bernotas.

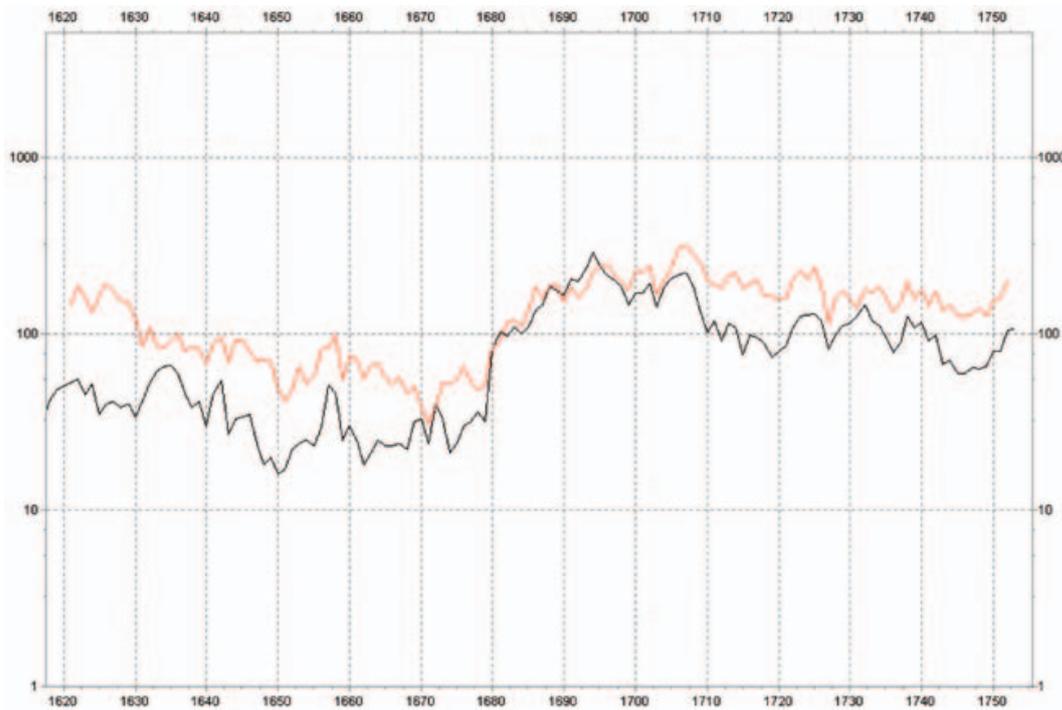
Fig 24. The mean ring-width series of 10 spruce samples of 2 Lutsu Street 1eslu204 (the red graph line) in synchronous position with mean spruce series of the Tampere House in Tartu (Student's $t = 9.21$, per cent of agreement $W = 69.1$ at 99.9 significance level). Abscissa – calendar years, ordinate – ring width in 0.01 mm. Alar Läänelaid.

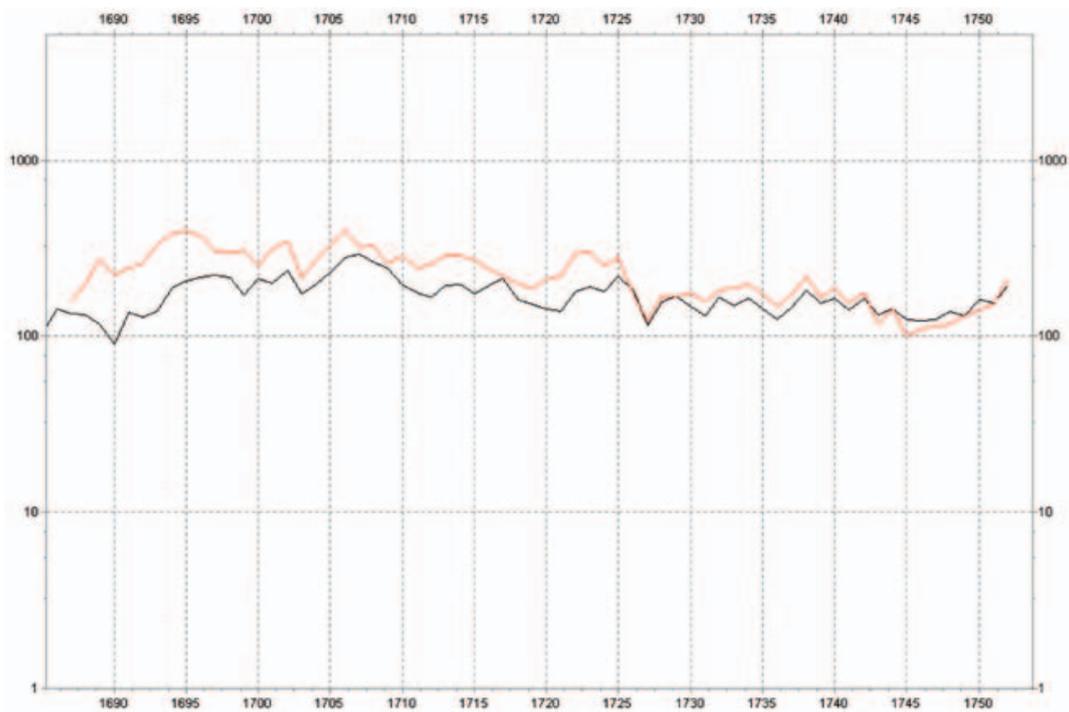
Fig 25. The mean ring-width series of 3 vertical beams 1eslu205 (the red graph line) and the mean ring-width series of 10 horizontal beams 1eslu206 in synchronous position. Note that both graphs end with the same year, AD 1752. Abscissa – calendar years, ordinate – ring width in 0.01 mm. Alar Läänelaid.

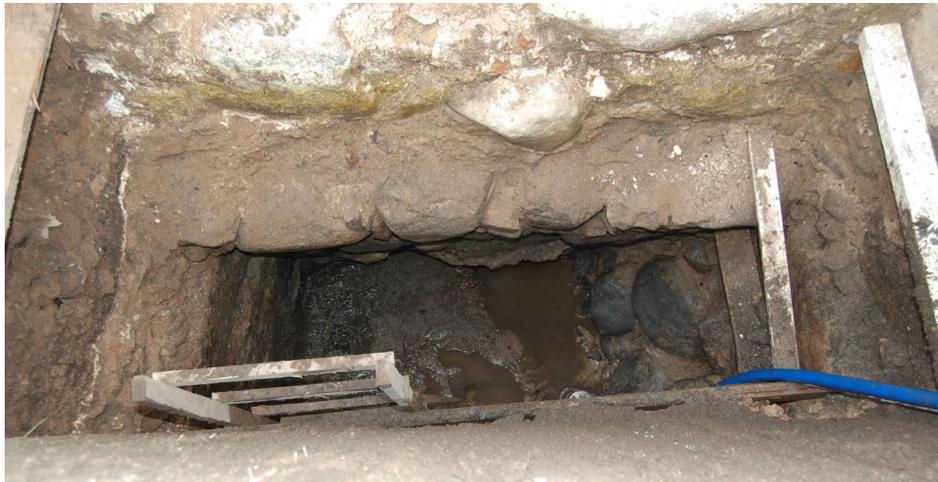
Fig. 3. Town wall in the excavation pit in Vabaduse Avenue (according to Bernotas 2010a). Photo by Rivo Bernotas.

The wall is stacked of stones, between which both fragments of bricks (Metsallik 1982, 3 f.; Metsallik & Tiirmaa 1996, 2; Piirits 2004, 3; 2005, 18 f.; Tvauri 2005, 3 f.; 2011; Bernotas 2010b, 3), intact bricks (Tiirmaa 1979; Piirits 1998, 5; Tvauri & Bernotas 2006b, 13 f.; Bernotas 2010b, 3) and limestones (Jonuks & Tvauri 1999, 5 f.) are attached. For cladding the parts of wall and

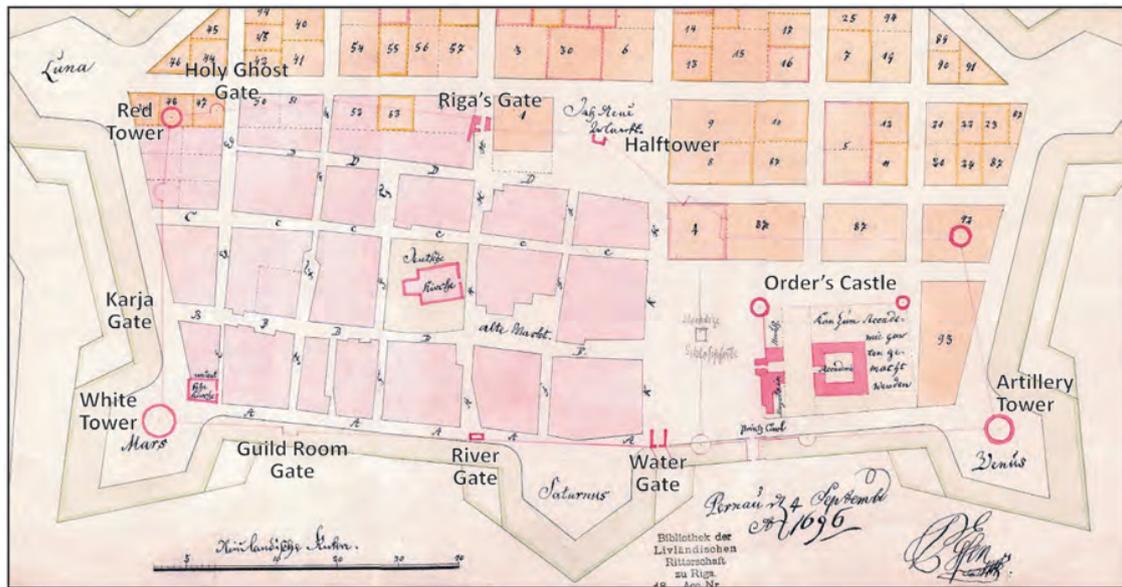
Fig. 2 Towers, gates and bastions of the town wall of Pärnu according to von Essen 1696. The plan is adjusted to the south (Riksarkivet Krigsarkivet 0406: 28: 039: 014; plan modified by the author).

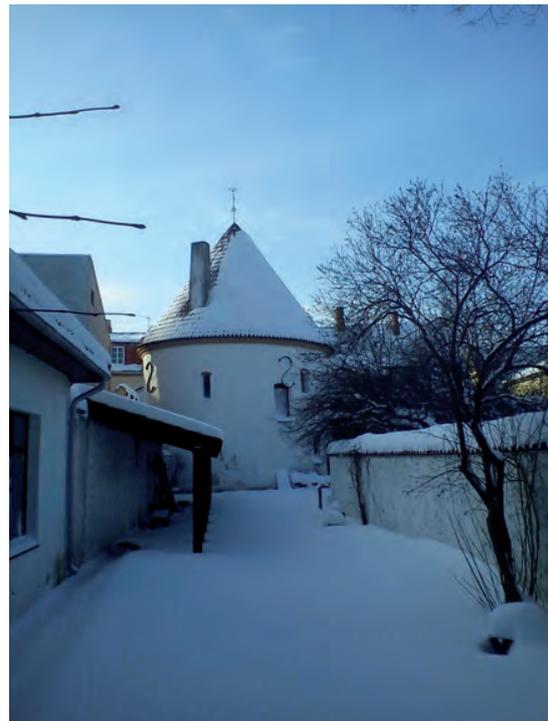
Fig. 4 Red Tower, view from the east (photo by the author).

Fieldwork in the immediate vicinity of the Red Tower (fig. 3, excavations 14; fig. 4) revealed that the thickness of the southern part of the town wall was 1.35 m and the eastern section of wall was 1.5 m thick.

The height of the wall from the original ground level was 3 meters; the final height was approximately 6.8 m, plus a part of the balustrades. The wall was built of fieldstones bound with brittle and porous lime mortar and was faced with bricks. The mortar used for bonding the bricks was tighter, lighter and stronger in concentration.⁶⁰ In the eastern section of wall, the gaps in masonry were tightly filled with clay. Since there was no such clay filling on the town side of the wall, it can be concluded that the walls were covered with damp proofing to prevent the rising of water from the moat, which was significant during periods of frequent rise in the river level.⁶¹ The thickness of the outer wall of the Red Tower extends to 2.5 m. The inner wall of the ground floor was lined with bricks.⁶²

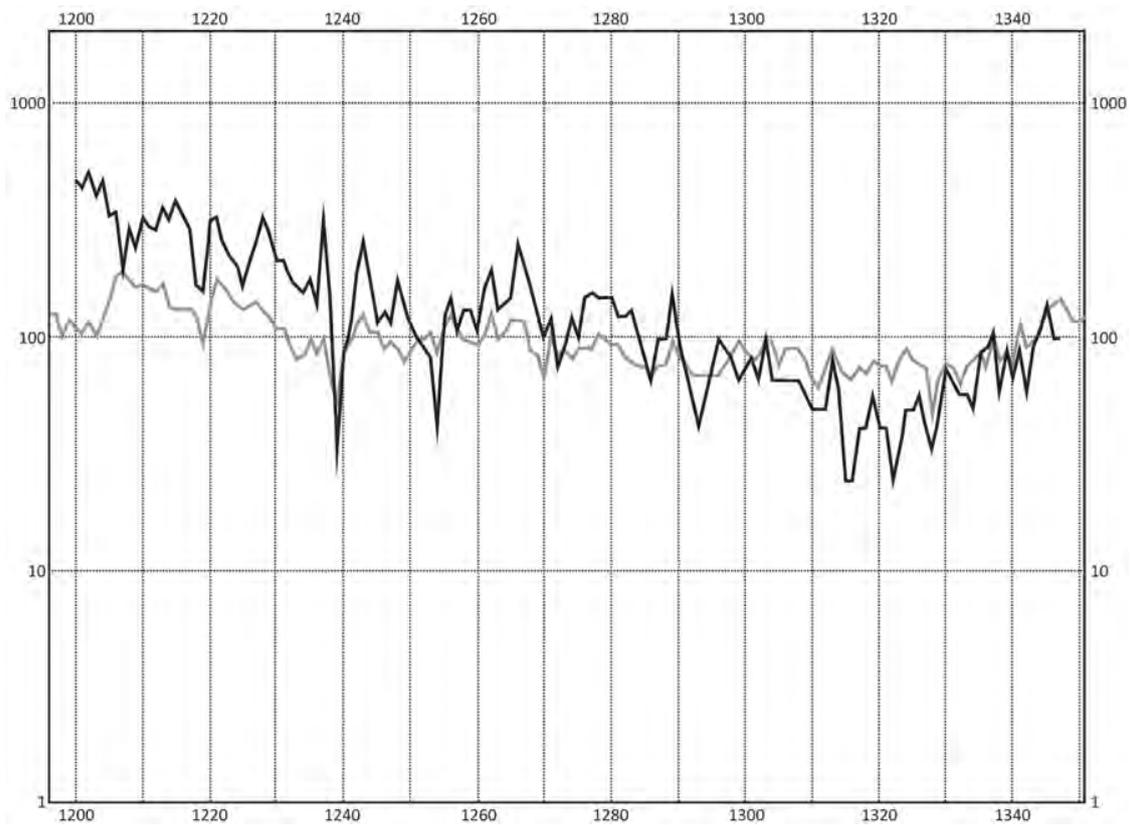
Fig. 5 Average of sample from Õhtu Street (*Õeppna1*, black line) in comparison with the Estonian pine chronology (*Zepester*, grey line). Y-axis marks the width of annual ring and x-axis marks the years.

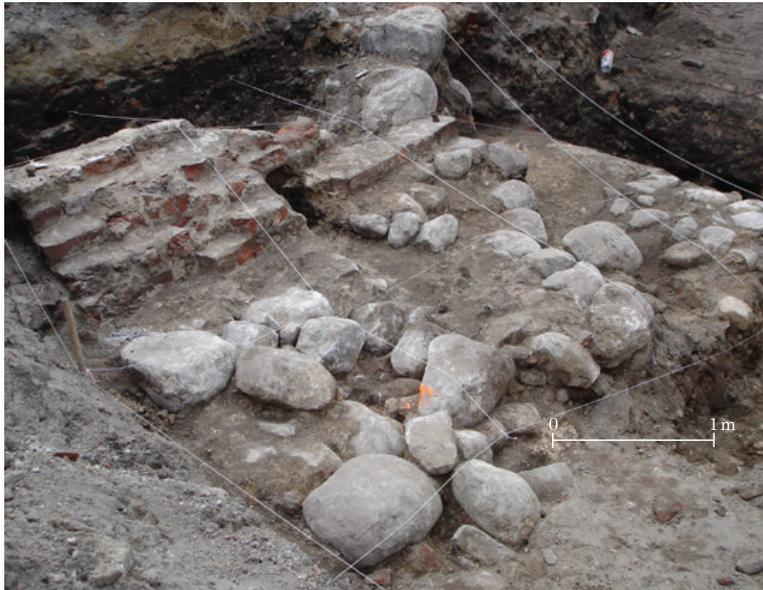
Fig. 2. Supposed section of town wall in the western side of the plot of Aida St 5. View from the north-east.

laying the stone pavement of Pühavaimu St in the 19th century and the northern part of the wall was probably demolished during the housing of the plot in the 20th century. In this way the archaeological material is considerably scarce and only the location of the unearthed stone formation on the same line with the parts of the town wall excavated so far allows us to suggest that the formation is a fragment of the town wall. We may assume that there was a gateway only on the basis of the town plans⁵ from the 17th century. The excavations destroyed the northern side of the wall fragment.

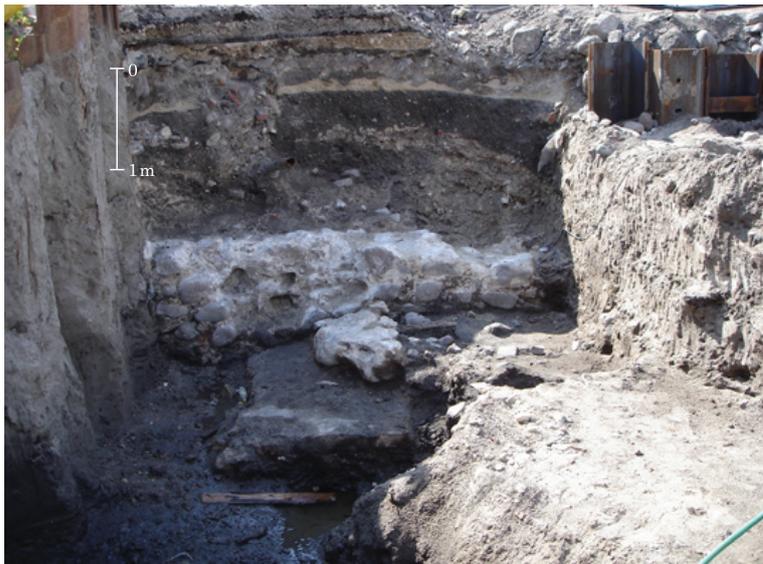
Fig. 3. Section of town wall on the plot of Aida St 5. View from the north.

Another, an up to 1.6 m wide piece of the town wall, was opened in Aida St 5 in the vicinity of the supposed wall fragment described above (Fig. 1: 2, 3). The wall has been built of boulders with the diameter of 25–30 cm joined together with lime mortar. A raft of logs orientated in the same direction as the stone formation was detected under the wall. The raft had only been preserved in the southern side of the wall fragment. Two parallel logs with the diameter of 30 cm (the southernmost being 2.5 m and the northernmost 2.9 m long) were unearthed directly under the stone layer. It is possible that this piece of the wall has also been a part of the gateway of the Guild room.

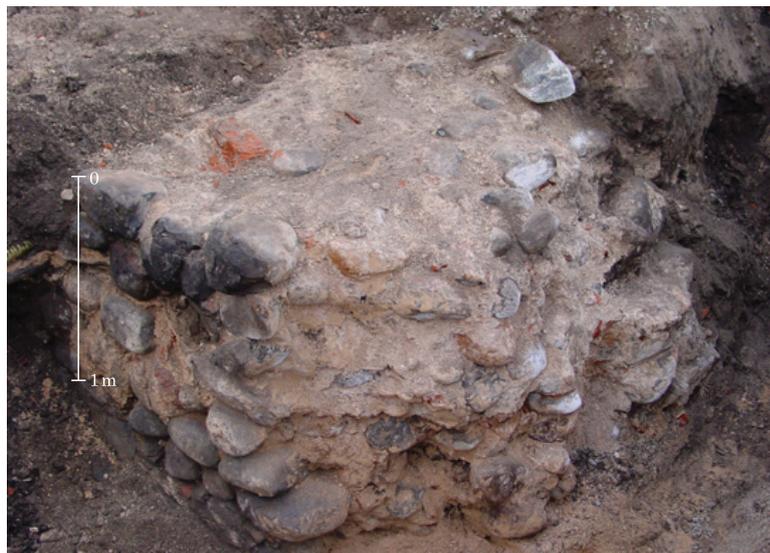
Fig. 5. Section of town wall in Hommiku St.

View from the south.

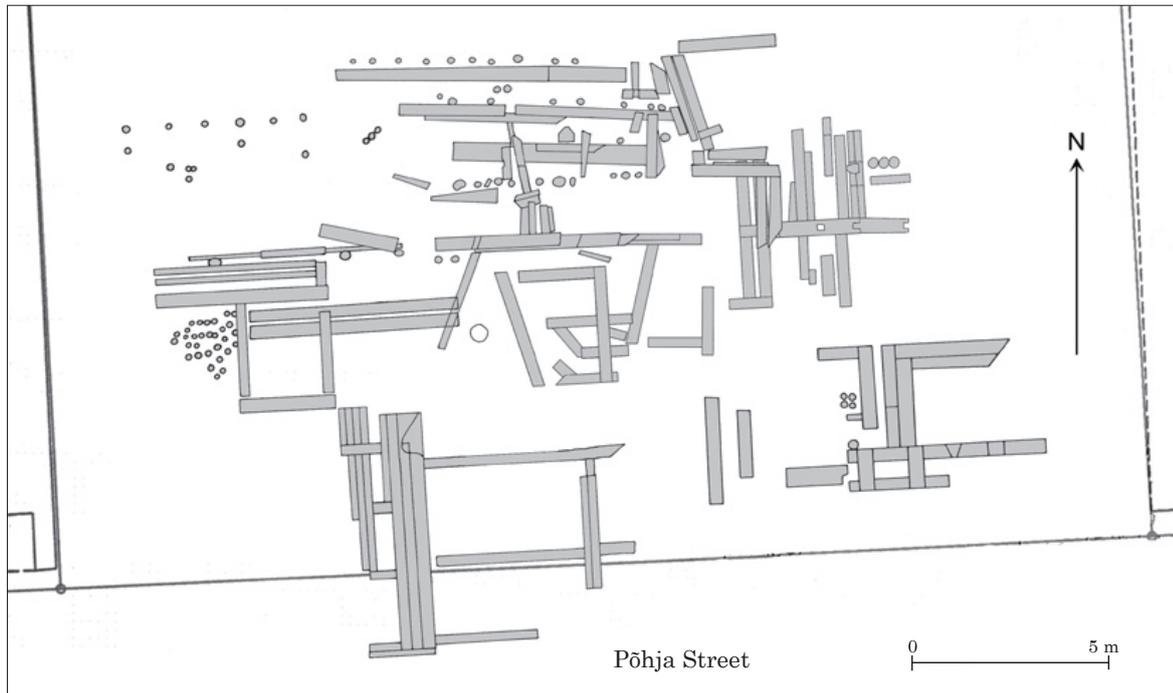
Fig. 8. Timber constructions of rampart fortifications.
 Jn 8. Muldkindlustuste puitkonstruktsioonid.
 Drawing / Joonis: Kristel Külljastinen

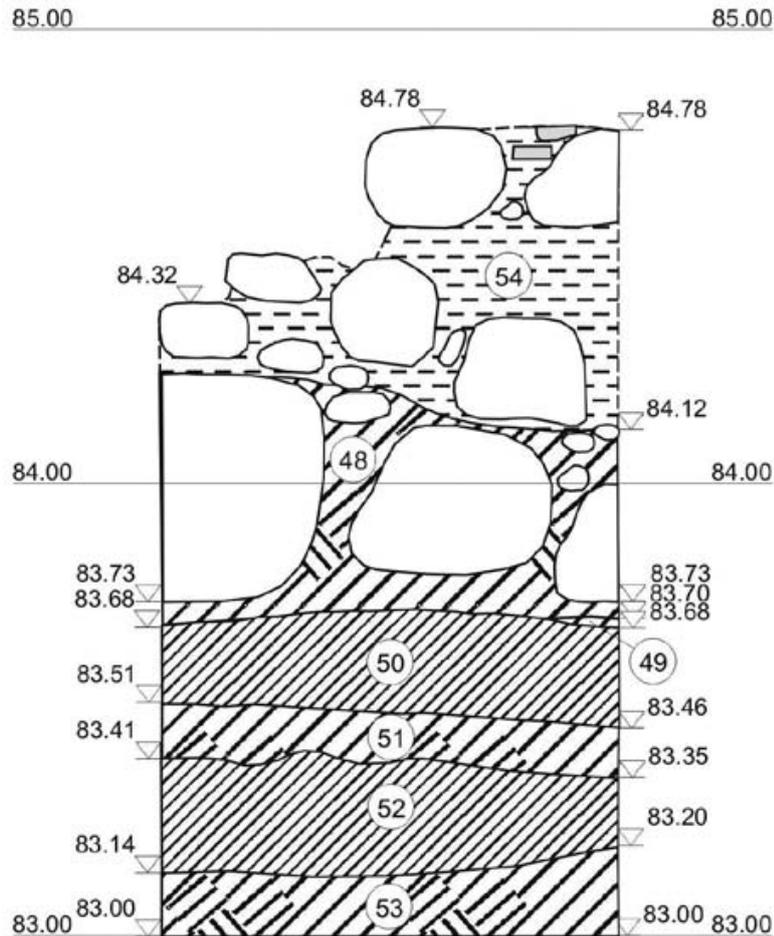
Figure 6. Surface layers under the town wall of Viljandi (according to Piirits, *Arheoloogilised uuringud Viljandis*): 48. beige layer of sandy clay (contained pebbles); 49. beige layer of sandy clay (contained patches of surface); 50. brown layer of clayish sand (contained abundant patches of beige surface, charcoal, pebbles, burned clay, and bones); 51. light brown clayish sand mixed with beige clayish sand (contained burned clay, charcoal, and pebbles); 52. brown clayish sand (contained charcoal and pebbles); 53. beige layer of sandy clay; 54. white lime mortar.

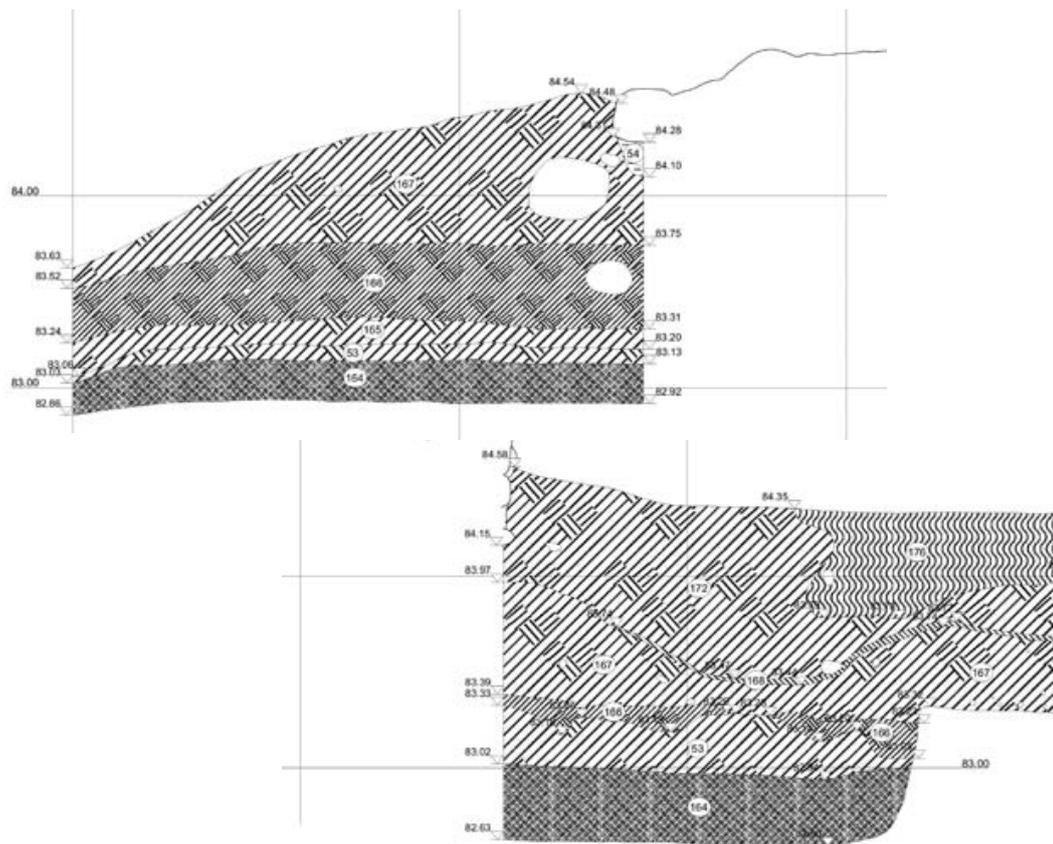
Figure 7. Town wall of Viljandi and the surface layers surrounding it (according to Piirits, *Arheoloogilised uuringud Viljandis*): 53. beige sandy clay; 54. white lime mortar; 164. layer of clay (contained patches of beige sand and pebbles); 165. beige sandy clay (contained patches of surface, rotten wood, and pebbles); 166. brown sandy clay layer (contained patches of beige sand, pebbles, brick dust, bones, and charcoal); 167. beige sandy clay layer (contained rocks, branches, and brick dust); 168. line of gray clayish sand (contained brick dust, charcoal, pebbles, rotten wood, patches of beige clayish sand, and surface); 169. light gray layer of clayish sand (contained rocks, beige sandy clay, charcoal, and brick rubble); 170. beige layer of sandy clay (contained rocks, patches of gray clayish sand, brick rubble, and charcoal); 171. gray layer of clayish sand (contained rocks, charcoal, brick rubble, roots, and patches of brown soil); 172. beige layer of sandy clay (contained rocks, pieces of bricks, charcoal, and patches of surface); 173. light brown layer of sandy clay (contained pebbles, roots, brick rubble, patches of surface, and charcoal); 174. gray layer of clayish sand (contained rocks, brick rubble, beige lime mortar, charcoal, and bones); 175. line of charcoal; 176. black-brown layer of soil (contained rocks, pieces of bricks and roof-tiles, roots, charcoal, lime mortar, and modern glass); 177. line of charcoal (contained brick rubble); 178. dark gray layer of clayish sand (contained abundant charcoal, bones, pebbles, brick rubble, slag, and rotten wood); 179. brown line of clayish sand (contained abundantly pieces of bricks, slag, and pebbles); 180. gray layer of clayish sand (contained charcoal; pebbles and pieces of bricks); 181. beige layer of sandy clay (contained rocks, pieces of bricks, charcoal, and patches of surface); 182. dark gray line of clayish sand (contained pebbles, pieces of bricks, and charcoal); 183. layer of mixed red clay (contained pebbles and patches of surface).

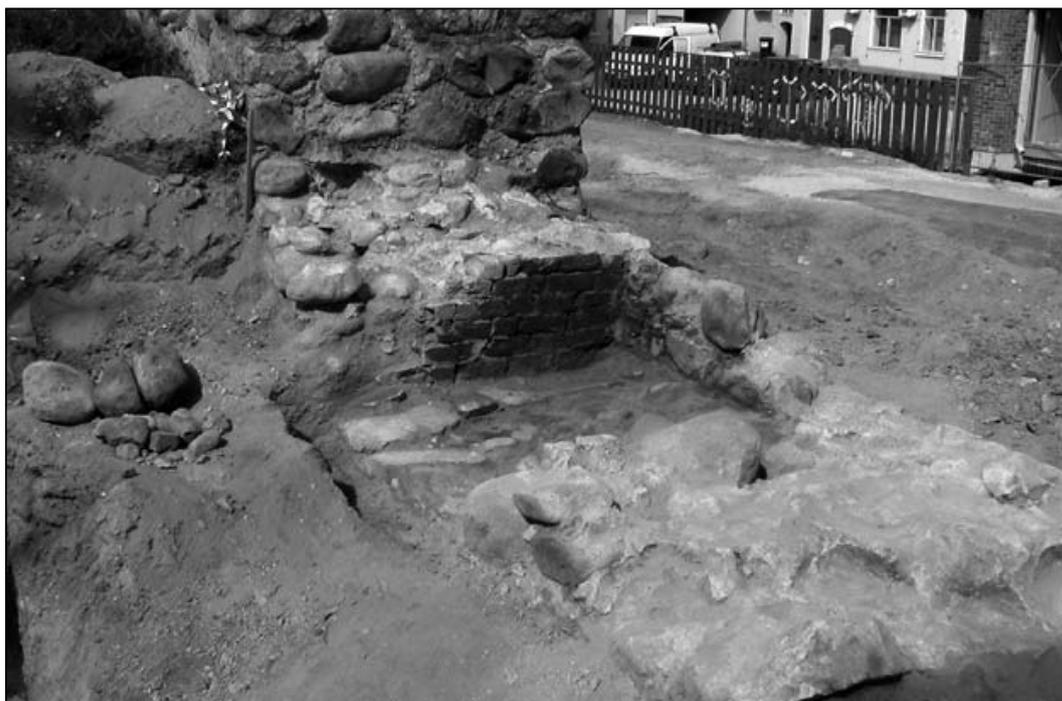
Figure 8. View of the niche in the town wall of Viljandi, view from the southeast. Photo by Peeter Piirits.

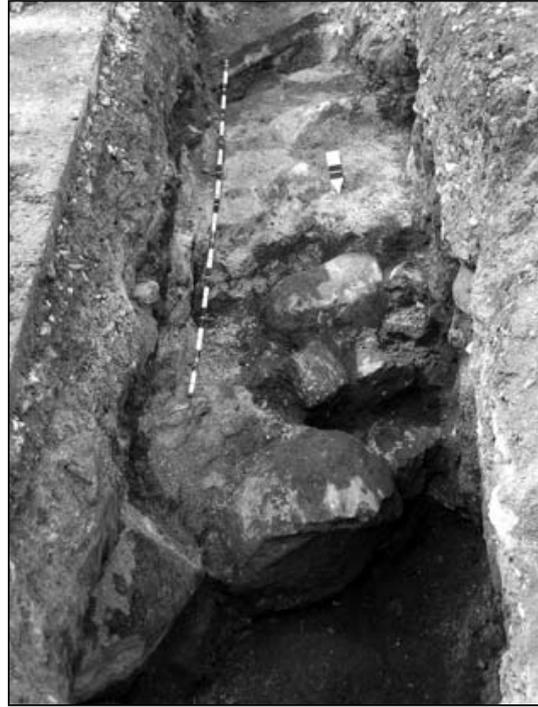
Figure 9. Town wall of Haapsalu at the crossroad of Wiedemanni, Rütli, Suur, and Mere Streets. Photo by Erki Russow.
