Witte Swaen from 1636. The Discovery and Archaeological Survey of an Intact *Fluit* in the Gulf of Finland, Baltic Sea

In 2020, the diving group Badewanne discovered an exceptionally well-preserved wreck in the Gulf of Finland, Baltic Sea. Researchers and divers from several different institutions collaborated to survey the wreck with the ambition of gathering as much archaeological information with as little impact on the wreck as possible. This paper summarizes the current state of research and argues that the wreck is the remains of a merchant *fluit* loaded with grain. Archival research has identified the ship as *Witte Swaen*, built in 1636 and sunk in 1638. Besides highlighting the fate of this particular *fluit*, the survey has revealed the characteristic hull shape as well as the sculptural decorations, which diverge from other later archaeologically surveyed *fluits* in the Baltic.

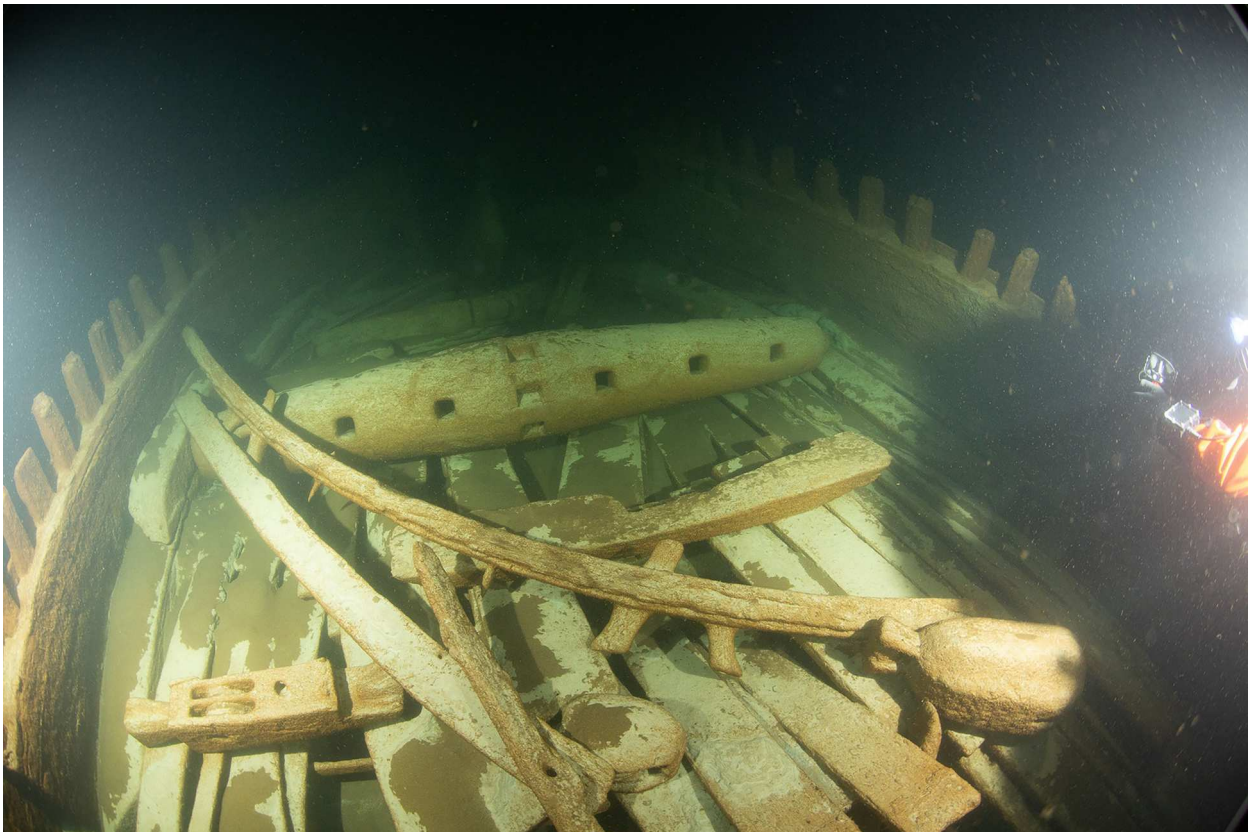
Figure 7. The windlass has moved slightly out of place. Note the beam with the pinrail and kevels as well as the knight (to the left) and an anchor buoy to the right (Jouni Polkko/Badewanne).

on the ship. For instance, the pawl bitt just before the windlass (Figures 3D and 7) has a notch to fit the foremast. The fore halliard knight is found loose on the deck towards the port side aft the windlass.

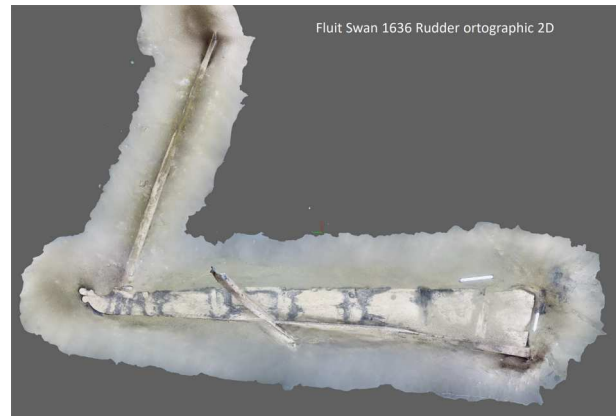
Figure 11. 3D model of the rudder with its still-attached tiller. Rudder is 8.3 m measured along the line of sternpost from the keel up to the trefoil carving on the top. The tiller is 5.0 m long (Jouni Polkko/Badewanne).

Witte Swaen’s rudder has come loose from the sternpost and is resting on the seabed astern of the wreck. Its upper end has a carved trefoil, a motif common on *fluit*-rudders (Figures 11 and 12). The motif was still common on the top of the rudder of Dutch vessels at the beginning of the 20th century.

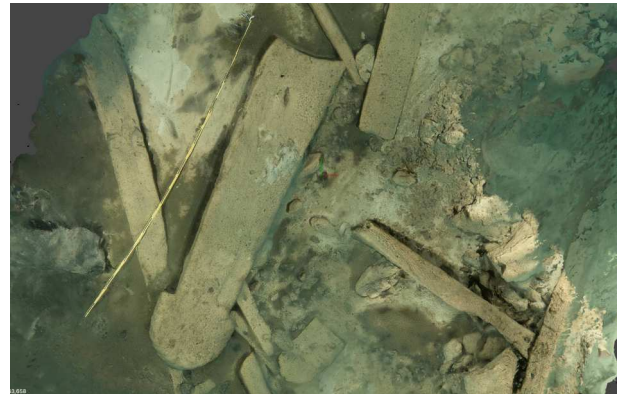
Figure 13. 3D model of the transom before it was turned around to reveal the carvings. Note the window shutter to the right of the transom (Ivar Treffner/Badewanne).

A 2 m-long and 50 cm-wide plank was of particular interest. It was found at the seabed, just astern of the sternpost. The contour of the plank suggested that it could be the transom, although unusually narrow compared to other, later *fluits*. One of the ends of this plank was rounded, and along this edge, the timber was carved to imitate cordage or rope. As the rest of the plank lacked any visible carved motifs, it was assumed that it rested upside down. Potential motifs could be found on the side of the plank facing down against the seabed. After thorough discussions within the research team and consulting the Finnish Heritage Agency, it was decided to turn the plank over to see if any motifs were on the other side. Before doing so, a photogrammetric 3D model of the area around the potential transom was created, and the area in the vicinity was searched for fragments of carvings (Figure 13).

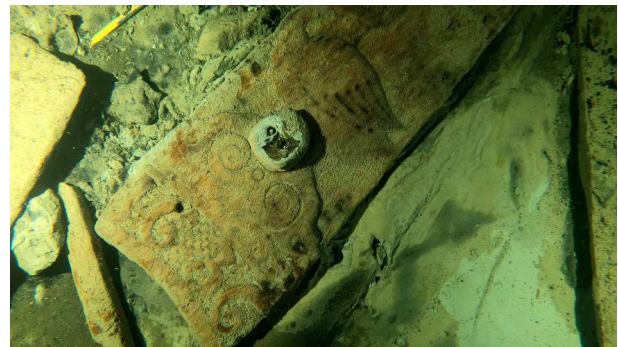
Figure 14. The inscription with the year of construction 1636 along the lower end of the transom. Note also the deadeye attached to transom (Ivar Treffner/Badewanne).

The remains of the chains that attached the shrouds to the hull are visible as rust encrustations on the outside of the hull. The starboard chainwale for the mizzen mast is still in place, whereas the others have come loose and fallen off. Several deadeyes used for adjusting the shrouds have been noticed scattered on the seabed by the wreck, and some are resting on the wales near their original position. One deadeye was discovered stuck on the transom (Figure 14).

transom due to corrosion. The bird stands on some carved ornaments. Underneath this motif, the year 1636 is carved, which informed us when the ship was launched (Figures 14, 15, 16 and 17B).

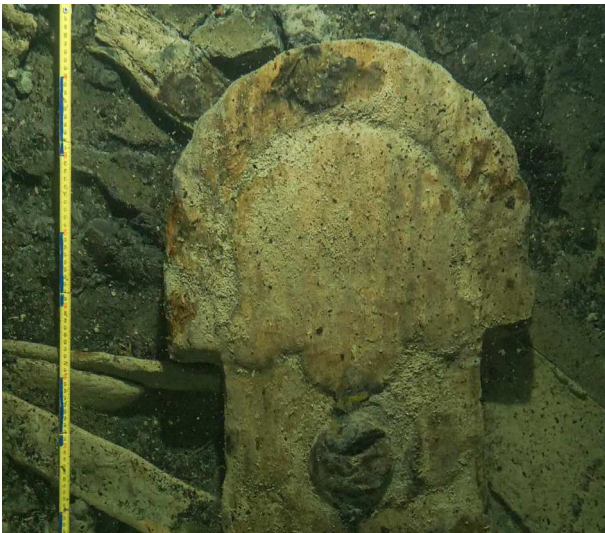
Figure 16. The upper end of the transom with its rope-like carving that runs around its edge. The staining centred in the upper end is probably encrustations of iron (Jouni Polkko/Badewanne).

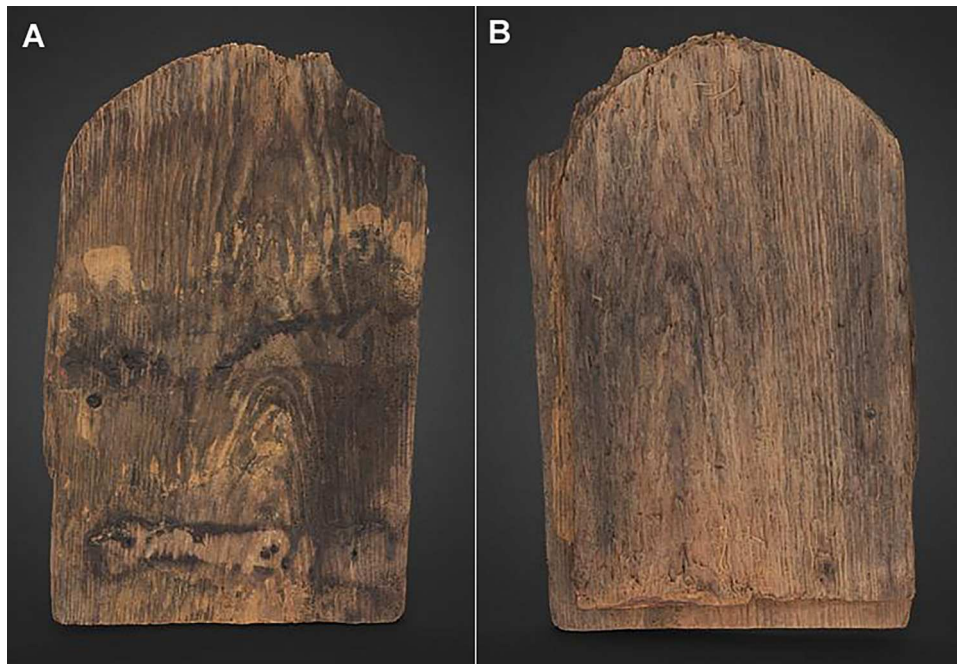
Figure 18. 3D image captures of window shutter prior to cleaning A. Hinge outlines on outer face, B. Inner face. The model was created in RealityCapture from 402 images in 02h:38m:15s (Ilari Järvinen, Finnish Heritage Agency).

Iron staining is notable but mainly localized to the lower edge, the curved side, and the outer face. In the latter, possible paint remains are uneven and covered in significant iron staining. Most interestingly, a distinctive pattern is visible on the outer face, initially thought to be bacteria-related staining, but upon closer inspection, it revealed intriguing details of the outlines of two parallel hinges, preserved as iron corrosion products. This is strong evidence, suggesting that the shutter opened like a typical window rather than in an upward fashion, as observed in some scale models of *fluits*. To what extent these openings have been equipped with windowpanes as well is not known, but there are evidence from other, later *fluits* that confirm this (Eriksson, 2014, pp. 59, 74, 91). Otherwise, the shutter was plain, with no decorative carvings, except for the lap at the edges, which was designed to ensure a better fit into the window opening in the hull. Due to the highly informative nature of the hinge outlines, the decision was made to retain this feature.

Before any intervention, the window shutter was 3D imaged and modeled by Ilari Järvinen, the Finnish Heritage Agency photographer. The model was created in RealityCapture from 402 images in 02h:38m:15s. Images 18 A and B show the shutter's outer and inner face sections captured from the 3D model.
