Fatigue performance of stainless tool steel CX processed by laser powder bed fusion

This study investigates the fatigue performance of additively manufactured steel CX under uniaxial high cycle loading. The results show that surface quality was the most influential parameter that changed the fatigue behavior of the material, compared to combinations of building orientation and heat treatment as other fabrication parameters. Consequently, improving the surface quality from $R_a = 3 \mu\text{m}$ – $1 \mu\text{m}$ increased the fatigue limit from 170 MPa to 250 MPa. However, heat treatment did not significantly influence the fatigue performance of the material, although it increased the hardness of the material from 320 HV to 460 HV.

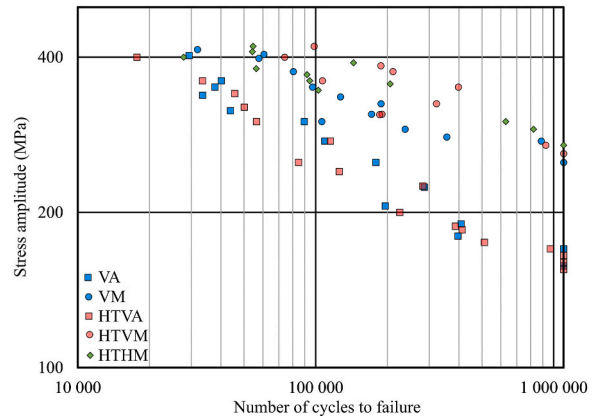
Fig. 2. $S-N$ data of L-PBF CX according to its fabrication procedure.

The stress amplitude-fatigue life ($S-N$) data of L-PBF CX are presented in Fig. 2. According to the results, L-PBF CX with raw surface had the most inferior fatigue performance, with or without being heat-treated. Therefore, the heat treatment did not improve the fatigue life of the material with the raw surface, and the surface quality had the dominant role in determining the fatigue performance of the material. On the other hand, mechanical machining increased the fatigue limit by $\approx 50\%$, regardless of the building direction and heat treatment condition, by improving the average surface quality from $Ra^1 = 3 \mu\text{m}$ and $Rz^2 = 20 \mu\text{m}$ to $Ra = 1 \mu\text{m}$ and $Rz = 5 \mu\text{m}$. In other words, although the heat treatment and horizontal building direction significantly improved the material strength under quasi-static unidirectional tensile loads [1], their combination had a negligible influence on the fatigue performance of the material in the HCF test. This phenomenon has also been observed in 18Ni300 as another additively manufactured maraging steel [12–14].
