INTERNATIONAL JOURNAL OF WOOD CULTURE

3 (2023) 64–85

Revealing the Innovations in Late Medieval Roof Structures of Finland

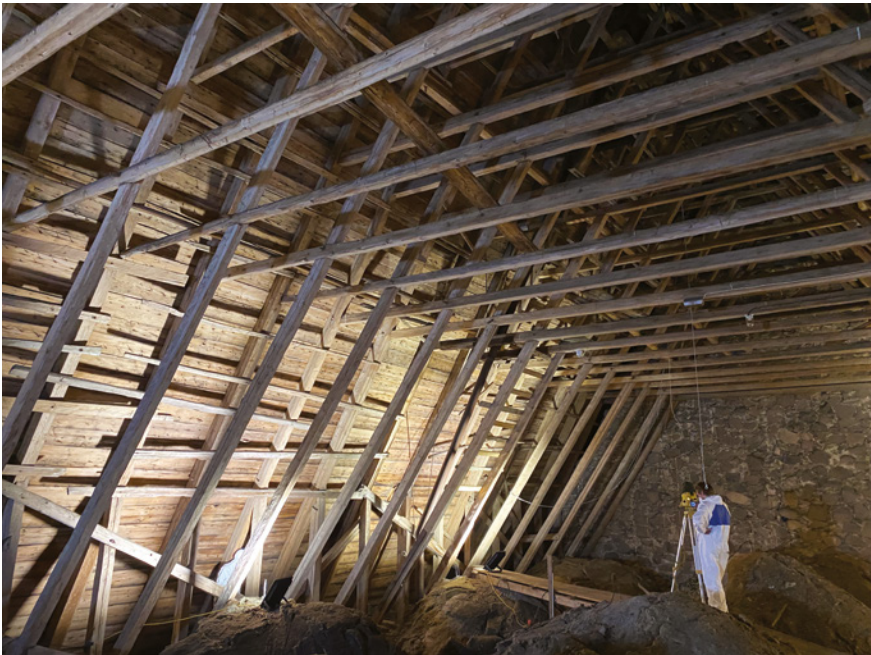
FIGURE 5 The roof structure of Pyhtää church (1461–1462d)
PHOTO: PANU SAVOLAINEN

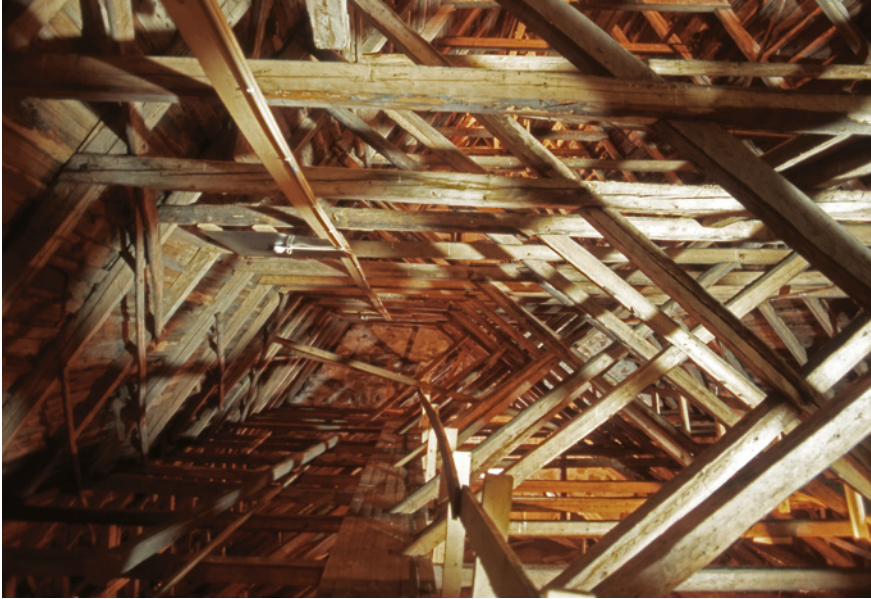
FIGURE 6 The roof structure of Pernaja church (1440d, 1452–1453d)
PHOTO: LIVADY

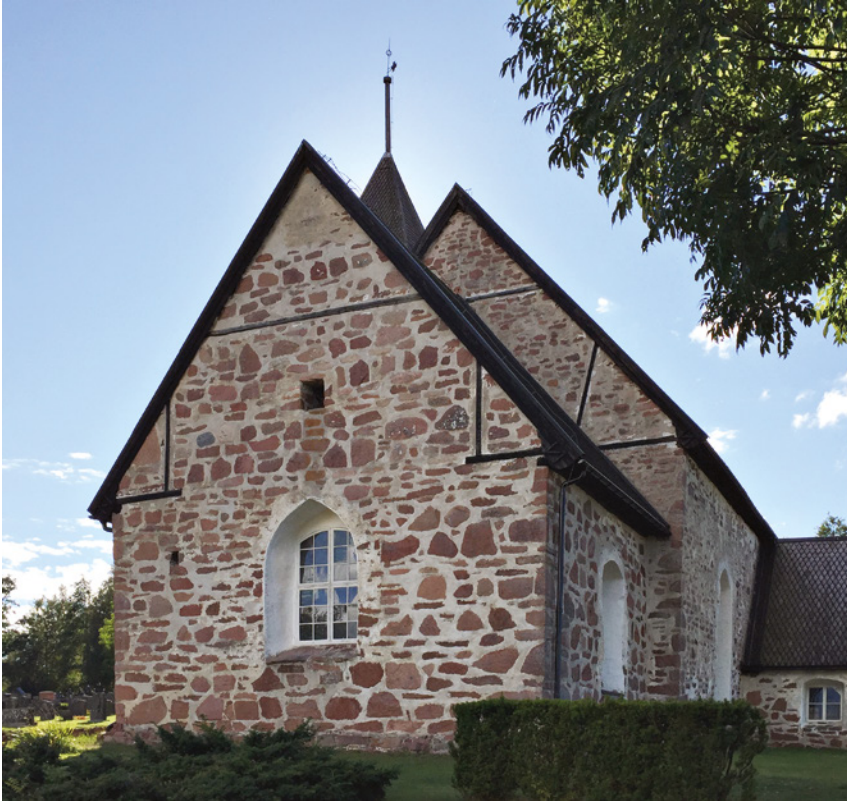
FIGURE 7 Hammarland church with both tie beam truss and rafter foot truss visible in the gables

The Hammarland Church on Åland islands is exceptional because the preserved roof constructions from the 15th century comprise both tie beam trusses and rafter foot trusses without tie beams. The nave of the church was built in the beginning of the 14th century (Hiekkanen 2014), but after the fire, the roof construction was rebuilt around 1440d according to dendrochronological data (Ringbom & Renner 1995). The construction of the nave in the 1440s is a tie beam structure (Figs 7–8). For some reason, the roof of the chancel was erected only later, in the 1460s. The roof of the chancel is a rafter-foot structure without a tie beam. Dendrochronological dating (Ringbom & Renner 1995) indicates that the timber was felled in 1465d.

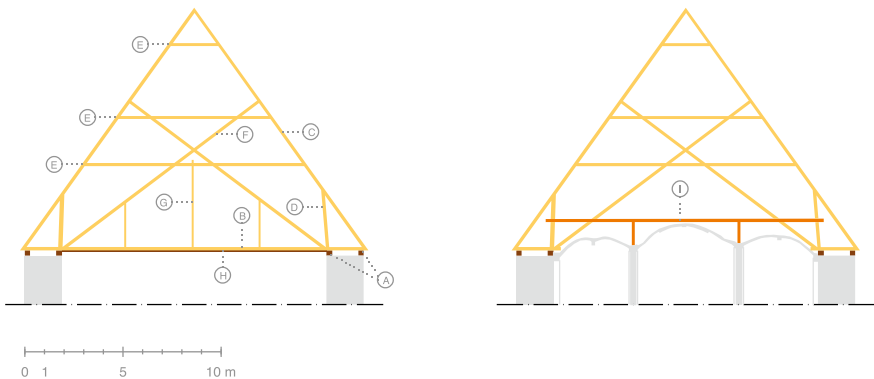
FIGURE 9 The alteration made to the roof structure of Pernaja church when the wooden ceiling was replaced with a brick vault (1440d, 1452–1453d)
DRAWING: PAULIINA SAARINEN

The construction of the vaults required major alterations to the original tie beam roof structure because the tie beams were removed, and newly raised ones were added to the structure. The structure is an amalgamation of tie beam and rafter foot trusses with scissor beams, and perhaps a testimony to the transition from tie beam trusses to rafter foot trusses (Fig. 9).

Based on the documentation, we were able to identify members of trusses that were added when the structure was modified to provide the space needed for the construction of brick vaults (Fig. 9). Dendrochronological samples were taken from this previously unidentified phase of construction related to brick vaults, which replaced an earlier wooden ceiling.

principle of the structure was changed to resemble the structural performance of a Gothic roof truss (Fig. 9).
