Effect of Laser Cleaning on EH36 Steel Surface Quality in Maritime Industry Applications

E Tourunen^{1*}, I Väisänen¹, O Iizuka¹, A Peuronen², N Kamboj¹, H Piili¹ and A Salminen¹

Abstract. This study examines the effect of laser cleaning on EH36 steel plates coated with epoxy paints. These materials are used in maritime applications, such as in shipbuilding. Paint layers were removed by using a laser beam generated by an IPG 100W pulsed nanosecond fiber laser with a wavelength of 1064 nm. The laser cleaning parameters included a pulse width of 25 ns, frequency of 100 kHz, and scanning speed of 450 mm/s. The tests were carried out using a laser power of 25 W, applying four or eight treatment cycles. Surface inspection was performed using a Bruker Alicona Infinite Focus G6 and a Malvern Panalytical Aeris X-ray diffractometer (XRD), along with visual evaluation. Results showed complete removal of paint layers, confirmed by visual inspection and XRD, with no damage to the base metal. Surface roughness values remained within acceptable limits for maritime industry standards. The mechanism of paint removal was identified as ablation, allowing layer-by-layer removal. This suggests that

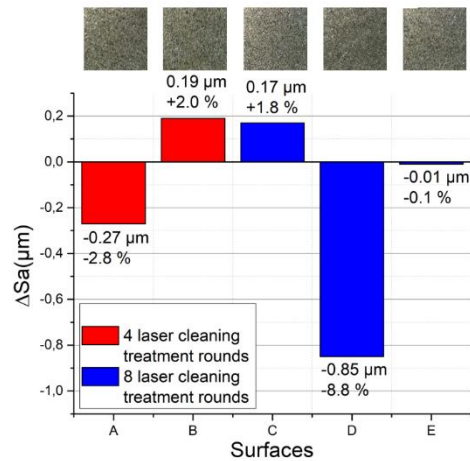
Figure 2. Change in S_a value (μm) for laser cleaned surfaces A–E compared to the reference surface.

Figure 2 shows the values that represent the calculated difference in S_a value relative to the reference. The effect of laser cleaning on the surface S_a value was small in the surfaces cleaned at 25 W laser power, for laser cleaned surfaces A, B, C and E. Figure 2 shows that laser cleaned surface D, with eight repetition times, had lowest value of S_a of $-0.85 \mu\text{m}$ in comparison to the non-cleaned reference surface. This was assumed to be due to surface smoothing caused by the laser beam affecting the base material surface, which may result from too high values of laser power of 25 W or if eight repetition times was too much. As seen in figure 2, laser cleaned surface A, with one paint layer, had a decrease in S_a value of $0.27 \mu\text{m}$ compared to the non-cleaned sandblasted reference surface, corresponding to a 2.8 % reduction. This change indicates that the laser beam did not affect the base material surface. As seen in figure 2, laser cleaned surface B, with two paint layers, had an increase in surface roughness of $0.19 \mu\text{m}$, corresponding to 2.0 % higher roughness compared to the non-cleaned reference surface. This increase may be caused by localized residues or incomplete coating removal, rather than changes in the substrate itself. As seen in figure 2, laser cleaned surface C, with three paint layers, had a S_a value increase of $0.17 \mu\text{m}$ (1.75%) compared to the non-cleaned reference surface, also suggesting minor surface roughening due to residues or incomplete cleaning. As figure 2 shows, value of S_a in laser cleaned surface D, with five paint layers, was $0.85 \mu\text{m}$, corresponding to an 8.8 % reduction compared to the reference. This indicates that surface has been smoothed, possibly caused by partial melting of the base material due to the eight repetition times in laser cleaning. As shown in Figure 2, surface E (with five coating layers and eight laser cleaning passes) had a S_a reduction of only $0.01 \mu\text{m}$, under 0.1%, indicating minimal effect on surface roughness. Across all samples, roughness changes ranged from $-0.85 \mu\text{m}$ to $+0.19 \mu\text{m}$ compared to the non-cleaned reference, suggesting the base material surface was not significantly altered. The minor change in surface E may result from thick coatings absorbing most of the laser energy. These results confirm that laser cleaning effectively removes coatings while preserving the original surface roughness, even under intensive processing conditions. The correlation between values of surface roughness and XRD measurements confirms that when the coating was successfully removed, the surface roughness remained unaffected, supporting that laser cleaning is based on evaporation of paint, and original roughness of surface remains constant.

Figure 2 presents the change in S_a surface roughness values of the laser cleaned surfaces compared to the non-cleaned sandblasted reference surface.

observations, showing that the effect of laser cleaning on the value of surface roughness was minor (-2.8 % – 2 %) all surfaces expect for laser cleaned surface D, which had four coating layers and eight laser cleaning repetition times. For this surface, the decrease in S_a value of 8.8 % was observed, indicating surface smoothing and possible melting of the base material surface. A significant observation was that in most cases the value of surface roughness remained close to the original sandblasted surface roughness value after laser cleaning, and laser cleaning did not cause melting-related changes to the surface. This study focused on uniform coatings, but real-world surfaces may be irregular or damaged, affecting cleaning efficiency. Adaptive parameter control and real-time monitoring can help maintain consistent results under such conditions. Offshore or in situ use also demands safety measures, including laser shielding, fume extraction, confined-space handling and explosion risk mitigation. In future, it would be important to further examine changes in the crystal structure and microstructure of laser-cleaned surfaces, for example, by electron microscopy and/or EBSD methods.
