# Retrospective Analysis of Artifacts in Cone Beam Computed Tomography Images Used to Diagnose Chronic Rhinosinusitis

**Abstract:** Background: Cone beam computed tomography (CBCT) is frequently used to corroborate the signs and symptoms of chronic rhinosinusitis (CRS). However, artifacts induced by dental restorations might complicate the diagnosis of CRS. Here, we assessed the frequency and location of artifacts in CBCT images taken to confirm the CRS. Methods: All CBCT images of the patients referred to the Emergency Radiology unit, Turku University Hospital, with an indication of CRS in 2017 were re-examined. The prevalence of the artifacts was analyzed in three cross-sectional views and three horizontal levels delimited by anatomical landmarks. Results: In total, 214 CBCT images of patients with CRS were evaluated. The diagnosis of apical periodontitis (AP) was impaired by artifacts present in 150/214 images (70%). The diagnosis of CRS was impaired in 5 of the 214 images (2.3%). The main origins of the artifacts were large dental fillings or crowns, and endodontic fillings were present in 95% (203/214) and 52% (111/214) of the images, respectively. Conclusions: AP as an etiol

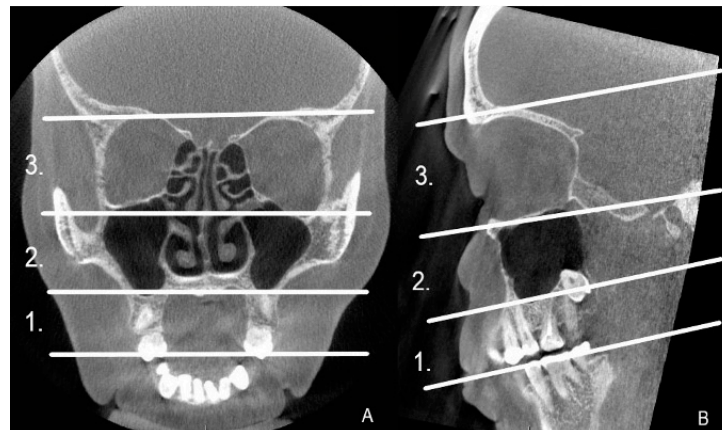
**Figure 1.** Coronal (A) and sagittal (B) view of the CBCT image divided in levels 1–3. 1. The area of the premolar-molar teeth and the alveolar ridge of the maxilla. 2. The area from the maxillary sinus floor to the orbital floor. 3. The area from the orbital floor to the orbital roof.

Analyzing the anatomy in the dentoalveolar area of the maxilla, at level 1 (Figure 1), required the recognition of the periodontal ligament space surrounding the premolar and molar roots, and endodontic fillings including the root canal posts were necessitated. Implants and dental crowns were recognized by their structure and shape in the CBCT images. A dental filling on the mesial, occlusal, and buccal sides of the tooth was defined as a large dental filling. Different materials such as amalgam, composite, or ceramic could not be differentiated in the CBCT images. AP of the maxillary premolar or molar was

diagnosed when a distinctly widened periodontal ligament or a radiolucent lesion was identified in the periapical area of the root. To analyze the anatomy of the maxillary sinus at level 2 (Figure 1), the cortex of the sinus walls, particularly the maxillary sinus floor, had to be visible. A mucosal thickening of 2 mm or more was needed to make the diagnosis of sinusitis. The same criteria were required for the other paranasal sinuses at level 3 (Figure 1).

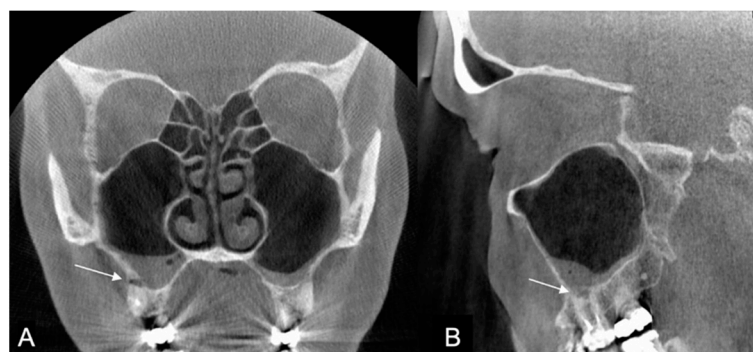
**Figure 2.** The coronal (A) and sagittal (B) slices of the CBCT image present sinusitis and distinct apical periodontitis of the root-filled right maxillary molar D16 buccal roots (arrow).

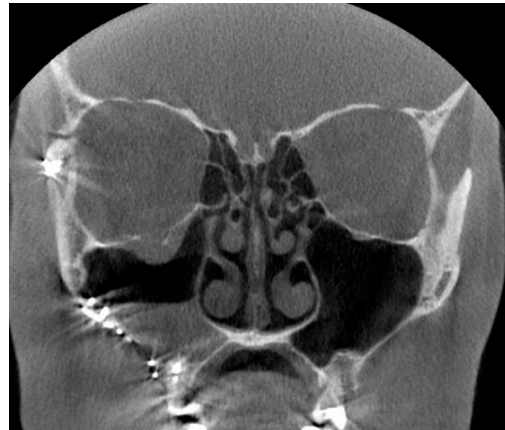
**Figure 3.** The coronal slice of the CBCT image shows artifacts induced by a metal plate on the right side of the maxilla.

At level 3, covering the sphenoid, ethmoid, and frontal sinuses, artifacts were recognized in only one image (0.5%) due to a metal plate in the maxilla (Figure 3). Artifacts were equally seen in all coronal, axial, and sagittal views. We also analyzed the interobserver reliability to detect artifacts. In total, 50 CBCT images were selected randomly to calculate the overall agreement of the interobserver reliability. The overall agreement to identify artifacts at level 1 was almost perfect, 0.960, 95% CI 0.90–1.00 (48 out of 50); at level 2, substantial, 0.560, 95% CI 0.42–0.69 (28 out of 50); and at level 3, also almost perfect 0.940, 95% CI 0.87–1.00 (47 out of 50).

prostheses and dental implants (Figure 8) causing the artifacts in 28/214 (13%) and 5/214 (2.3%) of the CBCT images, respectively. Other implants in the maxillofacial area were found only in three CBCT images, resulting in artifacts in levels 2 and 3 (Figure 3).

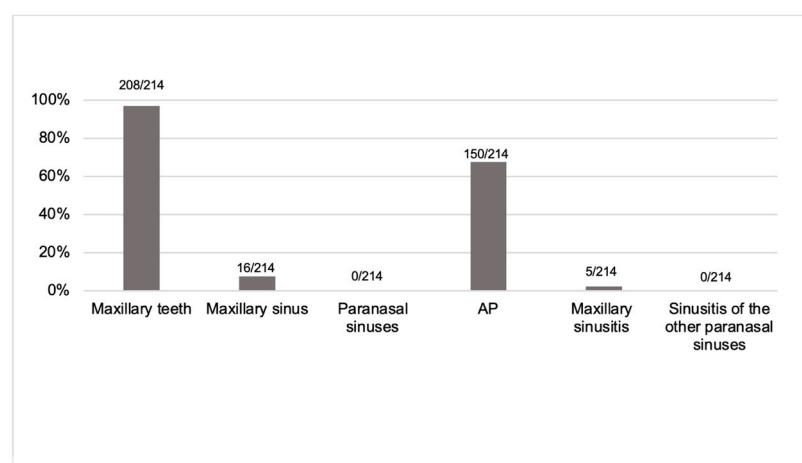
**Figure 4.** The prevalence of the CBCT images, where artifacts hampered either the evaluation of a given anatomic region or the diagnosis of apical periodontitis (AP) or sinusitis.

The obstacles of the artifacts are given in Figure 4. The interpretation of the anatomy of the maxillary teeth in detail was hampered in most of the CBCT images, i.e., 208/214 (97%). The detailed exploration of AP was complicated because of artifacts in 150/214 (70%) of the images. Artifacts complicated the recognition of the anatomy of the maxillary sinus in 16/214 (7.5%) of the images. The diagnosis of sinusitis was precluded due to an artifact in 5/214 (2.3%) of the images. Artifacts did not complicate the detailed evaluation of the anatomy of paranasal sinuses nor the diagnosis of paranasal sinusitis at level 3 (0%).

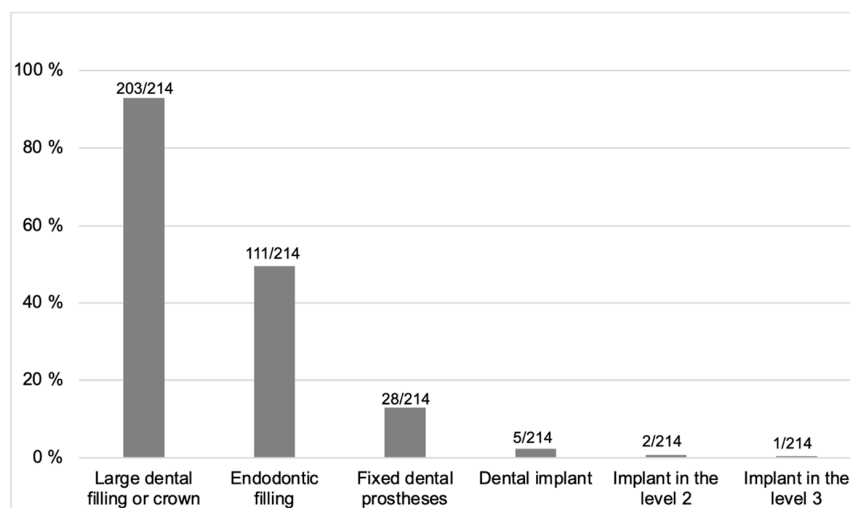
**Figure 5.** The origins of the artifacts.

The origin of the artifacts in the CBCT images is given in Figure 5. The main origins of the artifacts were large dental fillings or crowns in the upper jaw, being present in 203/214 (95%) of the CBCT images (Figure 6). Endodontic fillings of the maxillary teeth were the reason for artifacts in 111/214 (52%) of the images (Figure 7), followed by fixed dental

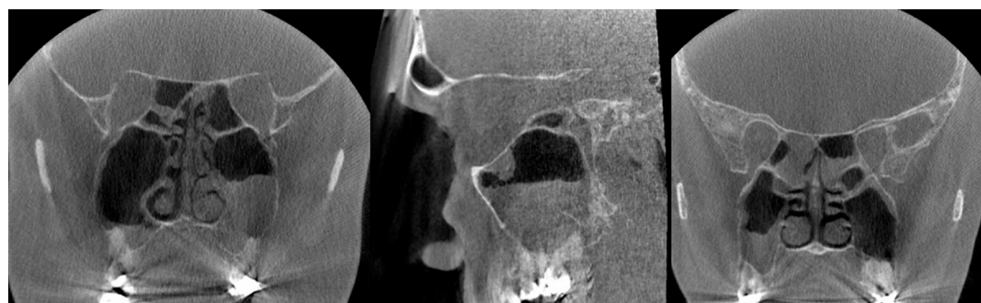
**Figure 6.** (Left): The coronal and sagittal CBCT slices present the signs of sinusitis and artifacts induced by dental restorations in the maxilla. Possible apical periodontitis cannot be distinguished accurately because of the artifacts. (Right): The coronal slice of CBCT image presenting mucosal thickening in the paranasal sinuses and artifacts induced by dental restorations hampering the evaluation of the periapical region of the teeth in detail.

In re-evaluating the 214 CBCT images, we found that artifacts are common in elderly patients, as most of them have had restorative dentition treatments with a wide range of materials used. As an example, the CBCT image given in Figure 6 illustrates the detrimental effect of dental restorations. The magnitude of artifacts in CBCT images caused by materials used in dentistry depends on the atomic weight of the material as well as the size and thickness of the object [22]. According to the literature, titanium implants are the source of detrimental artifacts especially in the CBCT images [15,23,24], as are also the Zirconia implants [25–27]. Fiber-reinforced composites (FRC), which are clinically used in cranioplasty surgery, seem to be without detrimental effects in the CBCT images [28]. We have shown earlier that composite materials which consist of at least 20% radio-opacifying BaAlSiO<sub>2</sub> fillers can cause artifacts in the CBCT images [29]. In the present study, there were only a few patients with dental (5/214) and maxillofacial implants (3/214), but as shown here, multiple dental implants cause deleterious artifacts (Figure 8).

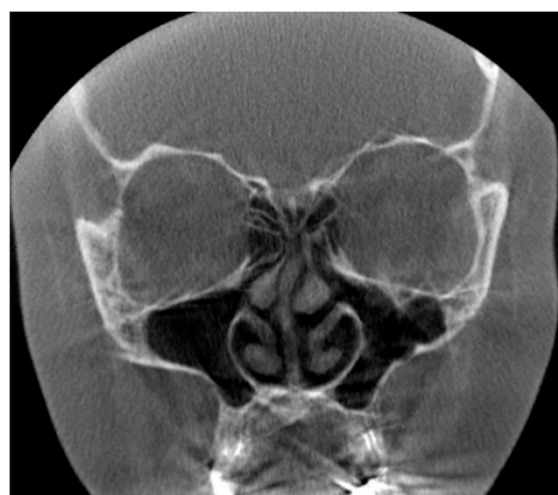
**Figure 7.** The coronal slice of the CBCT image presenting root-filled teeth in the maxilla and some artifacts originating from the fillings.

Here, we also showed that endodontic fillings such as gutta-percha and root canal posts caused artifacts in 52% of the CBCT images (Figure 7). However, their role in causing detrimental artifacts and in diagnosing AP remains partly unknown. When assessing root-filled teeth, it is difficult to judge whether the artifact originates more from the crown material, the root filling, or the root canal post material. Regardless of the origin, root-filled teeth should be checked extra carefully, as AP is more common in root-filled teeth, and teeth restored with crowns [31–34]. Furthermore, periapical lesions are also more common in molar teeth and the mesiobuccal roots of maxillary first molars [31]. Maillet and coworkers reported that the maxillary first molar was the tooth associated most with a change in the maxillary sinus floor (55%), followed by the maxillary second molar (34%), the second premolar (8%), and the first premolar (3%). This order is most likely a consequence of the close location of the maxillary molar roots to the maxillary sinus floor and the earlier eruption of the maxillary first molar, causing a greater risk of carious lesions [35].

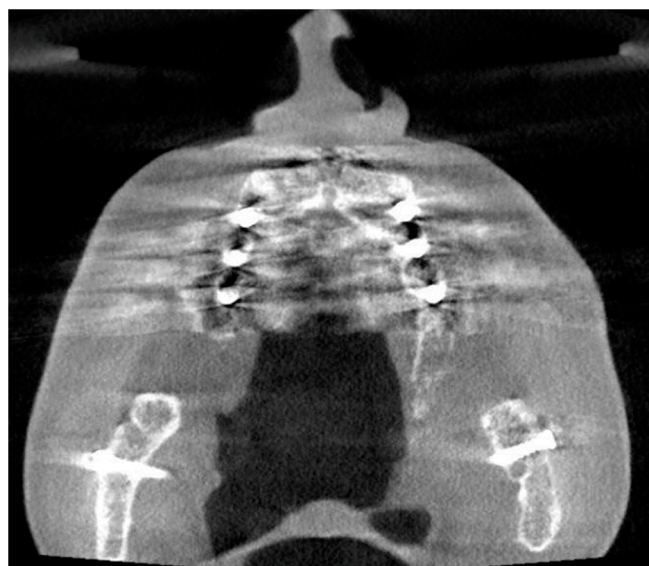
**Figure 8.** The axial slice of the CBCT image presents multiple implants causing a substantial amount of artifacts.

Due to artifacts, many authors still recommend intraoral images especially when dental implants are present, as seen in Figure 8 [40]. Therefore, a careful clinical judgment of the magnitude and materials used in dental restoration should be performed before referring patients for CBCT imaging.
